Client: Huffman Broadway Group, Inc.
Project Location: 11925 State Route 1, Point Reyes Station, CA
Inspection Date: November, 2024
Arborist: Ben Anderson

URBAN FORESTRY ASSOCIATES, INC.

Assignment

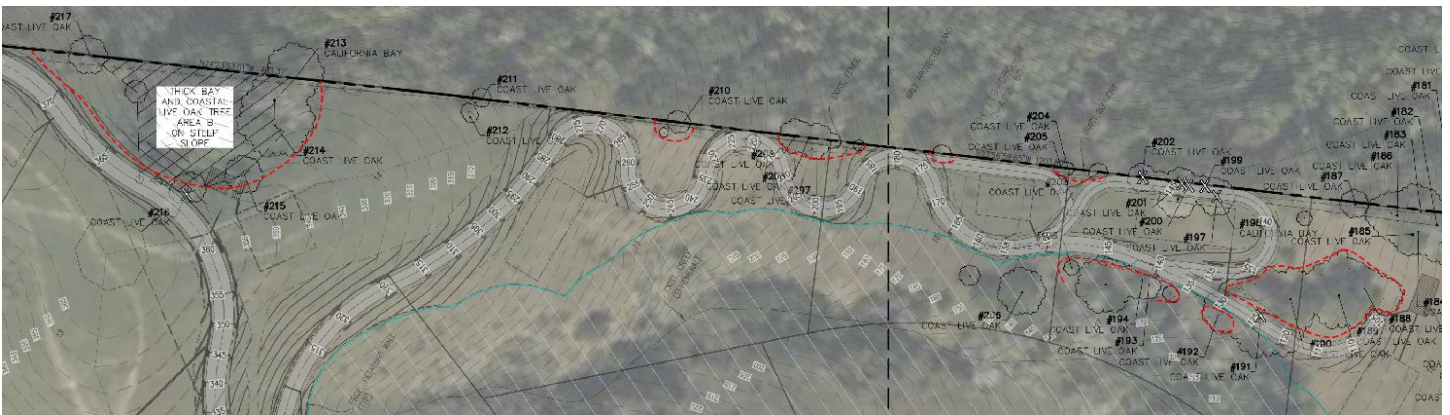
Figure 1. Map 1 of 2 shows the location for tree protection fencing (red dashed line). It is generally at the dripline of protected trees or the limit of excavation. No fencing is needed at the backside of the trees. Not all trees require fencing as the topography should serve to keep equipment away in many cases.

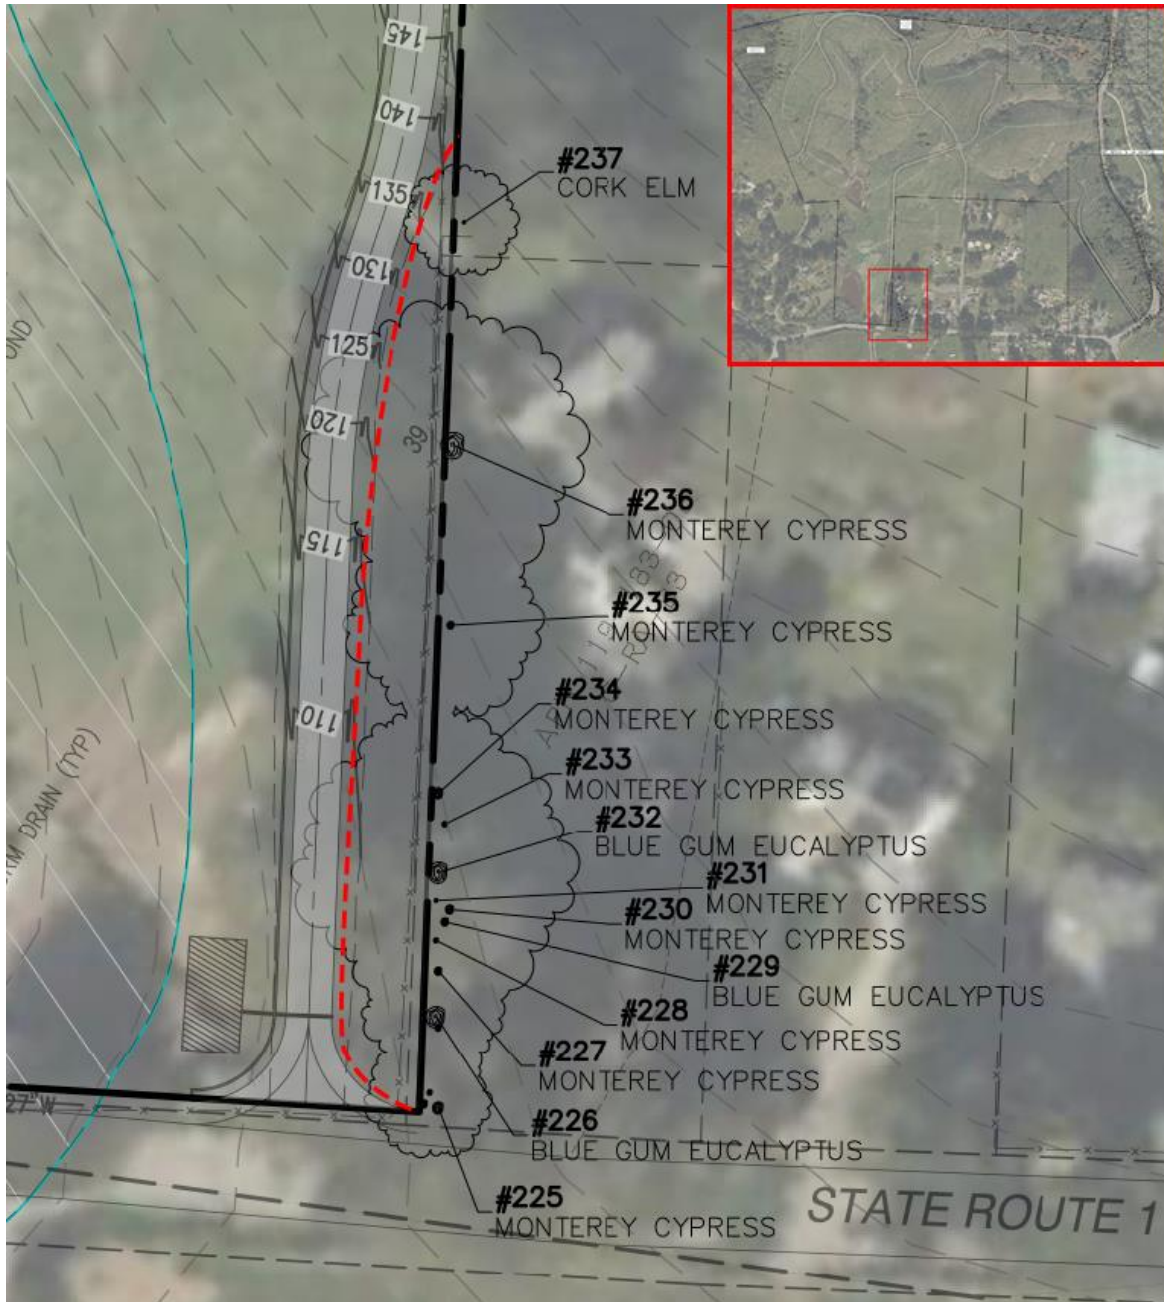
Figure 2. Map 2 of 2 of required tree protection fencing.
