City Ventures Auburn Grove Development

Preliminary Tree Preservation Report

PREPARED FOR:

Douglas Wildman
Western Division Consulting Arborist
ISA Certified Arborist #WE-5500A
ISA Tree Risk Assessment Qualified

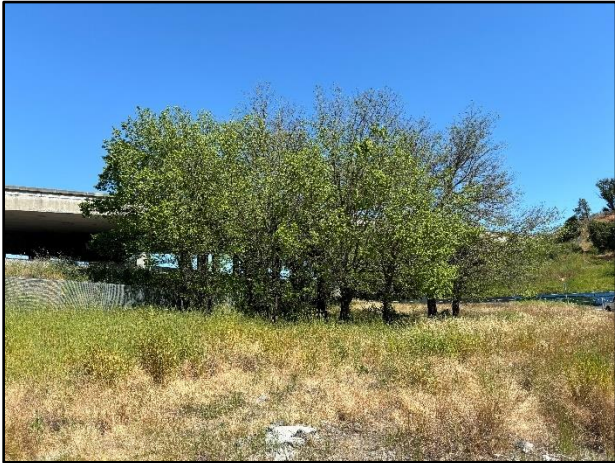
Photo 1: North side of Woodland Avenue had a grove of American elm (*Ulmus americana*) #29, 31-45 in the northeast corner of the site at the corner of Woodland Avenue and Auburn Street.

structure. Most of the elms were growing along the Smart Train chain link fence and four of them were interacting with the fence (photos 1 & 8).

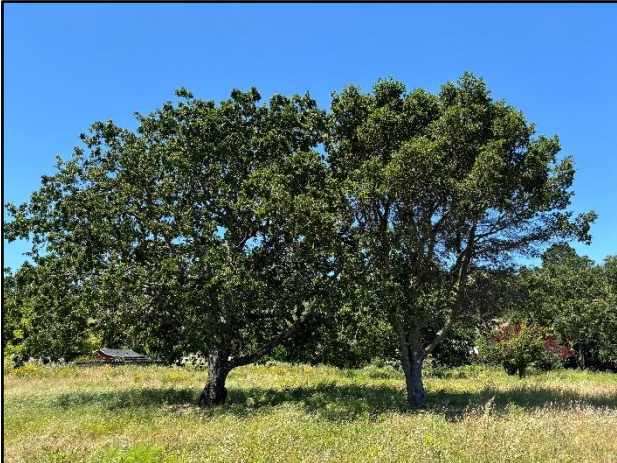
Photo 2: South side of Woodland Avenue had 16 native oaks including coast live oak #26 (right) and valley oak #27 (left) and many mature nonnative plum trees.

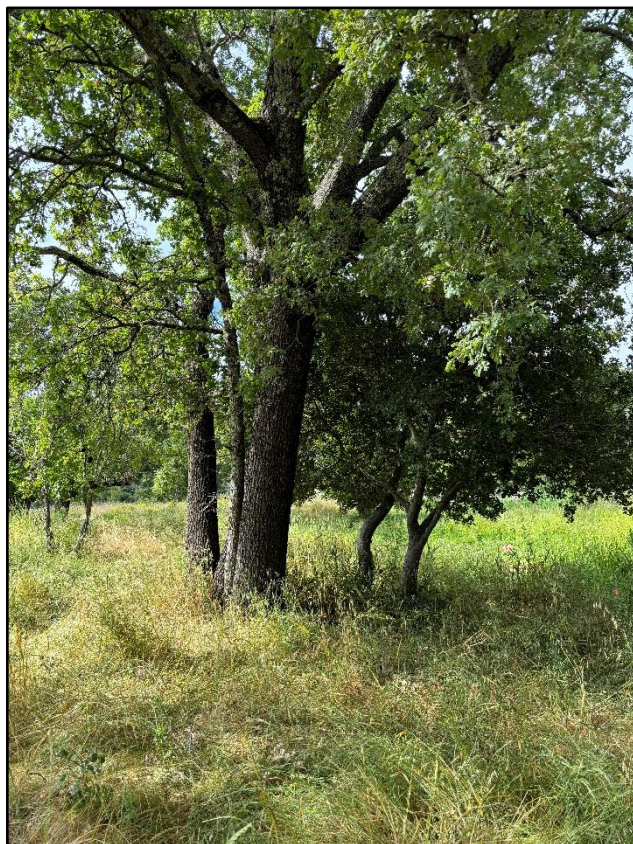
Photo 3: The large, mature, multi-stem valley oak #2 (left) was in good condition and suppressed the two small coast live oaks #3 & 4 which were in poor condition.

Of the 4 trees to be preserved, three were in good condition and one was in fair condition. (American elm #29, off site). Coast live oak tree #48 is outside the project area. Coast live oak #2 is within 5 feet of the project area and valley oak #18 is within 10 feet. Construction is planned within the calculated Tree Protection Zones of trees #2 and 18. I anticipate the presence of roots (>1") in this area. Measures to mitigate damage to these trees, including soil compaction, must be taken as detailed within the specific recommendations below.

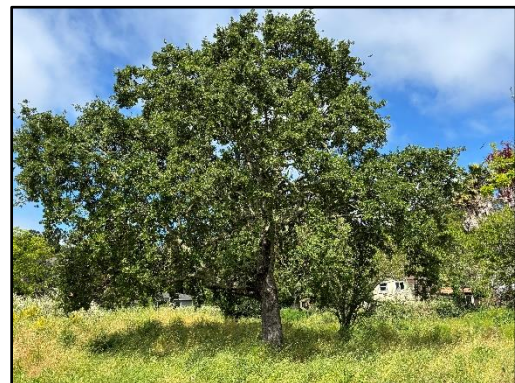
Photo 4: Valley oak #7 was semi-mature and in good condition.

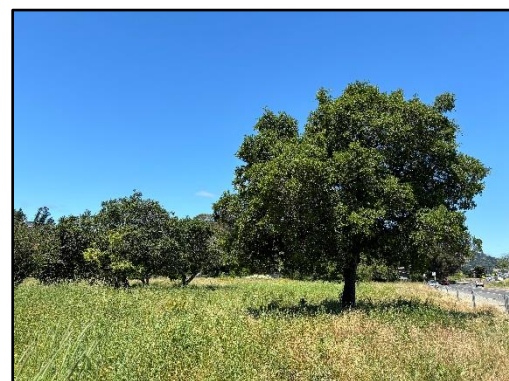
Photo 5: Coast live oak #22 was semi-mature, in good condition and grew near Woodland Avenue.

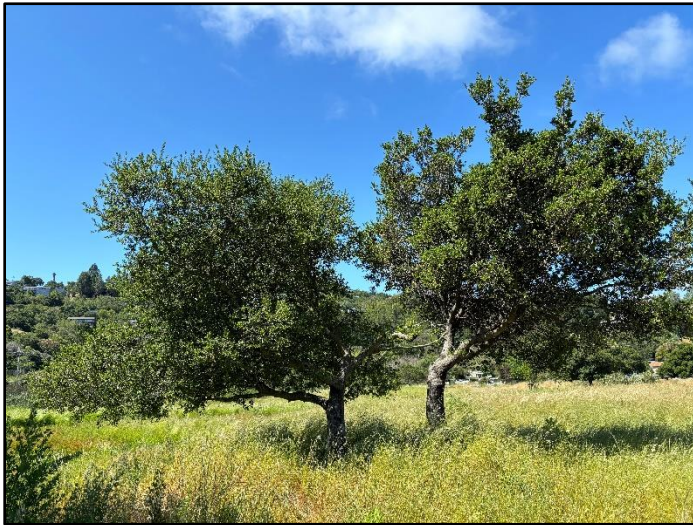
Coast live oaks #12 and #13 were moderately vigorous, displayed dark green foliage and had cracked branches, cavities in the stems, and a sweep with poor structure (photos 6 & 7). One mature valley oak #21 had low vigor, good form and poor structure with minor dieback, co-dominant stems and gall insects (photo 9).

Photo 6: Two coast live oaks #12 (right) and #13 (left) were in poor condition with asymmetrical crowns and cavities in the main stem.

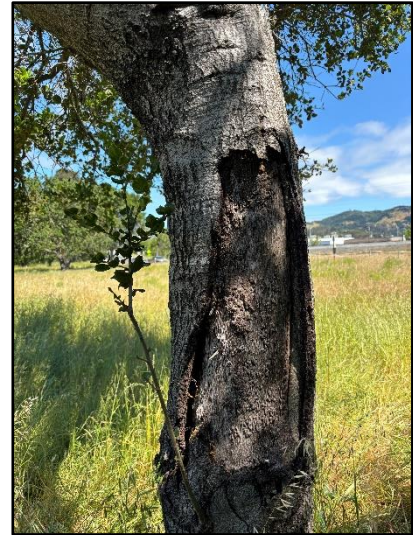
Photo 7: Coast live oak #13 had a large wound in the main stem.

13	Coast live oak (Quercus agrifolia)	12	Young	Small	Poor	Good	Vigor 3; form 3; structure 2; Cavity in stem; cracked branch; sweep; dead branches < 2 inches.
14	Coast live oak (Quercus agrifolia)	16	Semi-mature	Small	Good	Good	Vigor 3; form 3; structure 3; Dead branches < 2 inches.

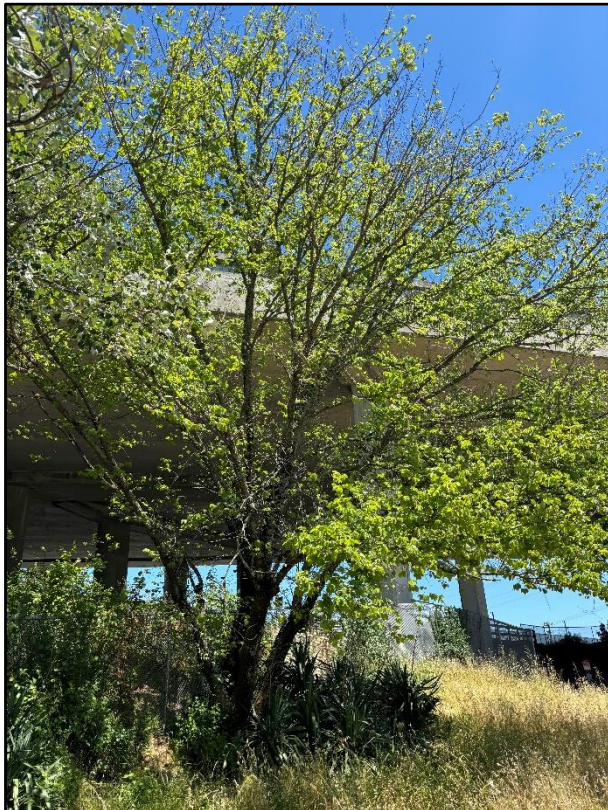
Photo 8: American elm #29 was multi stem and in fair condition growing away from the Smart Train chain link fencing.

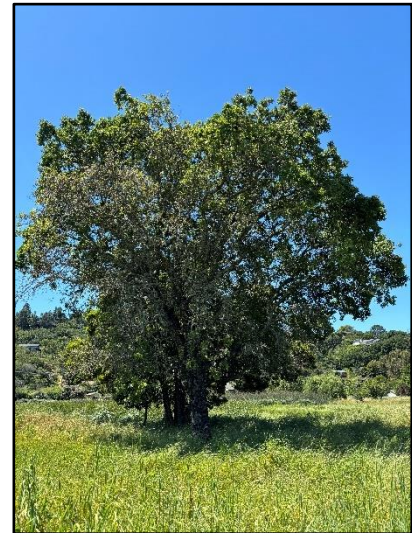
Photo 9: Mature valley oak #21 displayed low vigor and was in fair condition.

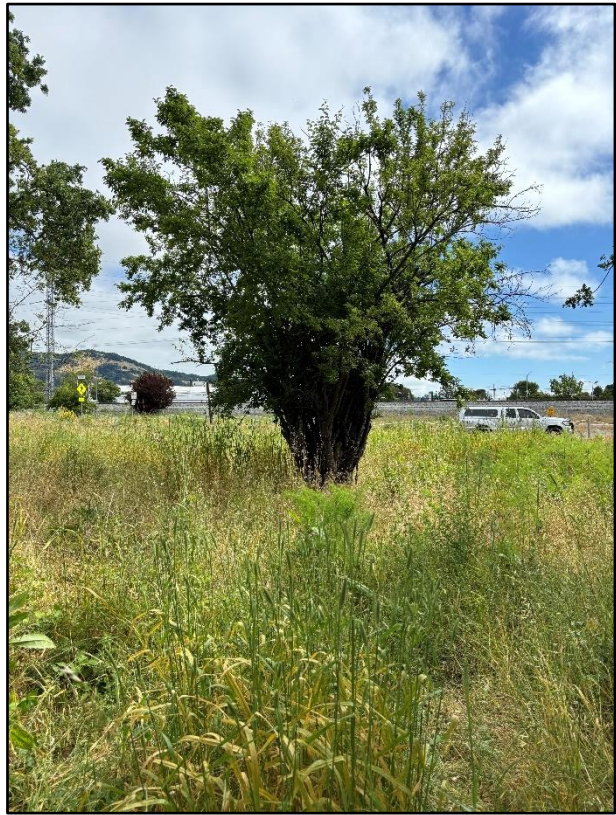
The third most common species was cherry plum (*Prunus cerasifera*) located throughout the property. All 12 trees were small, mature in poor condition, with poor branch structure, decay and dieback (photo 10). Cherry plum tree #9 was engulfed in poison oak.

Photo 10: Cherry plum #5 was in poor condition with co-dominant stems, included bark, and moderate dieback. It was typical of all cherry plums on site.

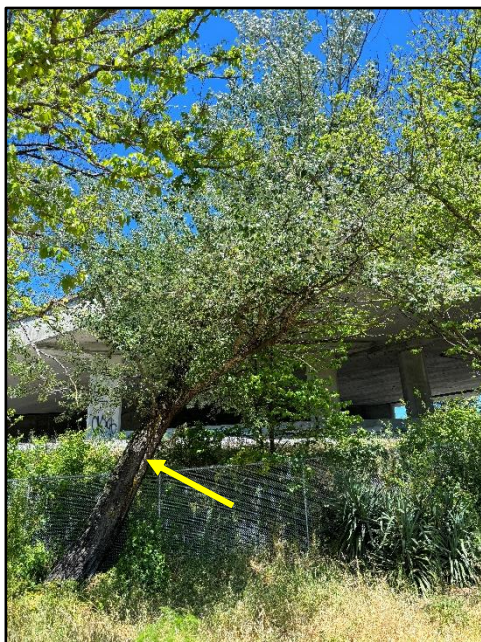
- The European white poplar #31 leaned over the Smart Train chain-link fence where its crown grew completely within the Smart Train easement. It had root decay, dead branches over 2 inch diameter and was in poor condition (photo 11).

Photo 11: European white poplar (*Populus alba*) #31 leaned over the Smart Train fence and easement (yellow arrow).

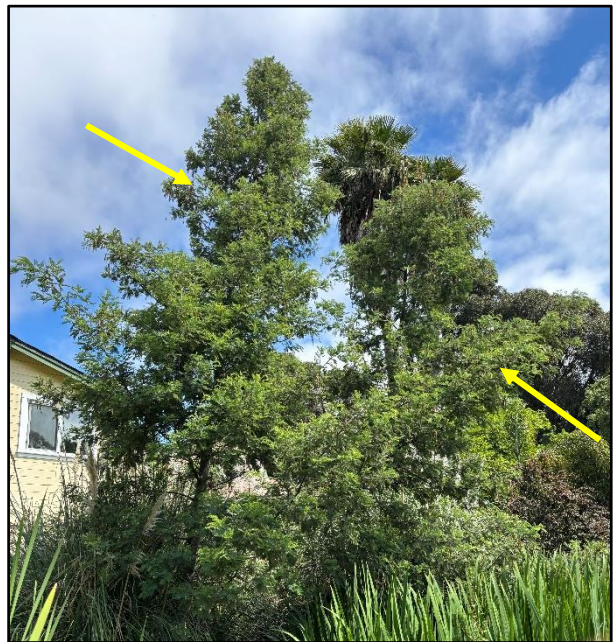
Bailey’s acacia (*Acacia baileyana*) was represented by two trees: tree #10 grew within the seasonal wetland on the west side of the property (photo 12) and the other grew on the north side of Woodland Avenue near the Smart Train fence (tree #46). Both trees were over-mature and in poor condition, showing stem failure and root flare cavities.

Photo 12: Bailey acacia (*Acacia baileyana*) #10 grew vigorously beside the seasonal wetland. Two stems grew from its failed main stem (yellow arrows).

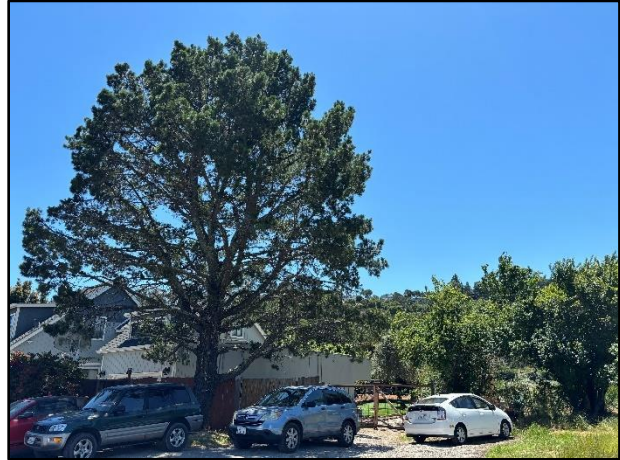
- Monterey pine (*Pinus radiata*) #28 was mature, and grew along a wood fence near Woodland Avenue (photo 13). It had low vigor with moderate dieback and dead branches over 2 inches diameter with a sweep to the west.
- Blackwood acacia (*Acacia melanoxylon*) was overmature and in poor condition with a decaying main stem and decay in the root flare.
- Willow (*Salix* sp.) grew above the seasonal wetland on the south portion of the site (photo 14). It was in poor condition with severe dieback, a cavity in the main stem and dead branches over 2 inches diameter.

Photo 13: Monterey pine (*Pinus radiata*) had low vigor, moderate dieback and was in poor condition.

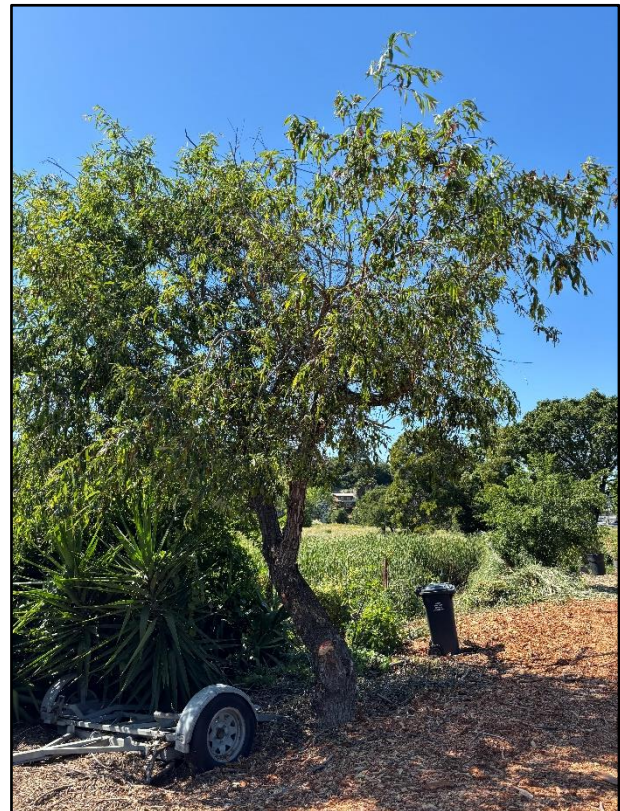
Photo 14: Willow (*Salix* sp.) #49 had severe dieback and was in poor condition.

Of the four trees that may potentially be preserved, tree #15 was in fair condition and within 5 feet of the proposed construction. One half of its TPZ was within the area of disturbance. Trees #47, 49 and 50 were growing outside of the project area but were in poor condition.

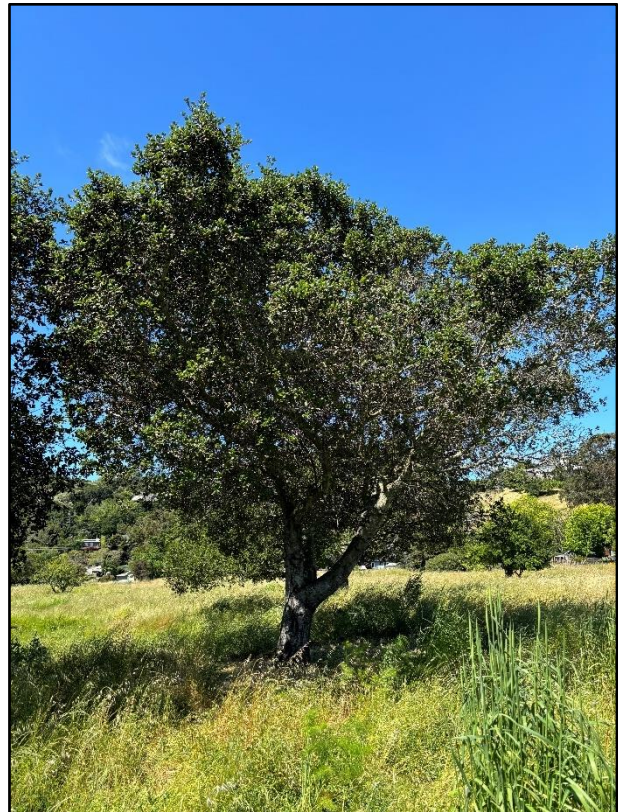
Photo 15: Coast live oak tree (#14) will be preserved. Special protection measures for all trees to be preserved must be enacted if trees are to survive construction without significant impacts.
