# Preliminary Arborist Report

## Fernwood Cemetery Expansion Mill Valley, CA

January 2026  
Revised April 2026  
**Revised July 2026**

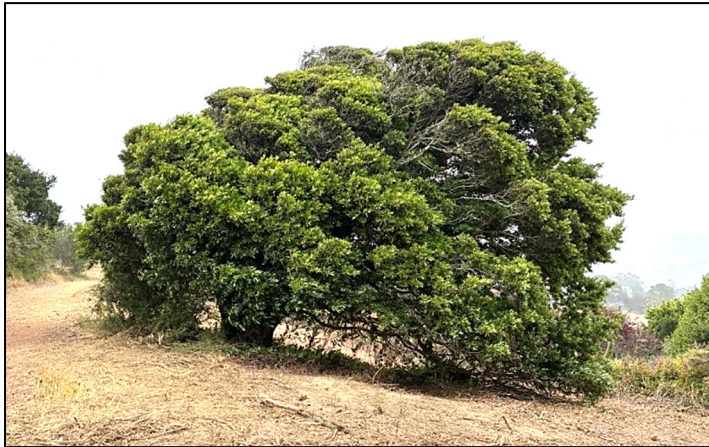
spreading crowns (Photo 1). Fifty-eight (58) bays were in good condition with large vigorous crowns. Eleven were in poor condition with sparse growth or extensive dieback. Stem diameters ranged from 6 to 33 inches.

**Photo 1** (above). California bay #4404 had a spreading base with multiple stems and windswept crown.

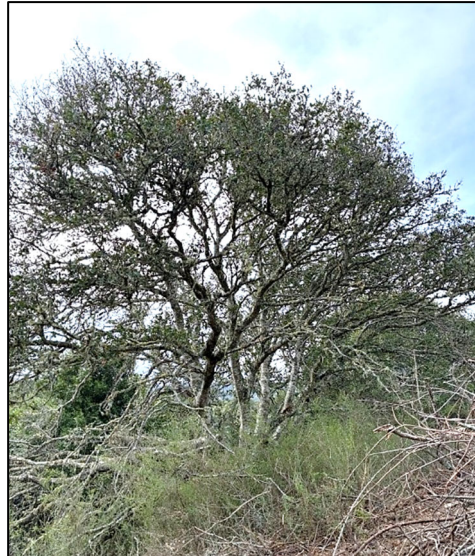
**Photo 2** (right). Coast live oak #4458 was a Heritage-sized tree with a sparse open crown.

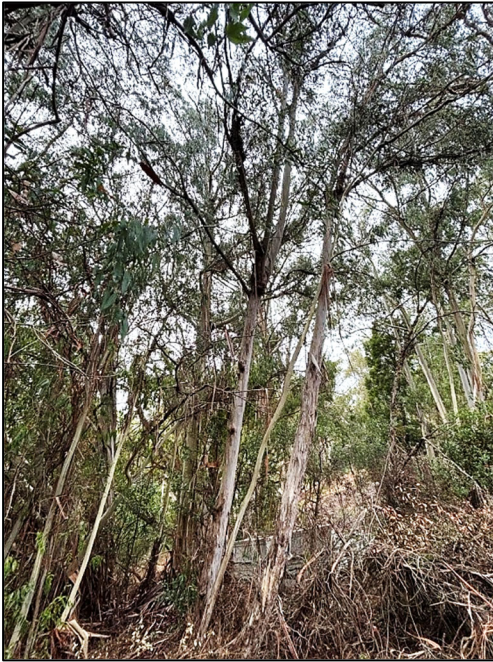
Forty-seven (47) river red gums were growing predominantly near the base of the western slope, close to the existing cemetery (Photo 3, next page). Stem diameters were 9 to 51 inches, with an average of just under 21 inches. Over half (27 trees) were in fair condition with high crowns. Many trees were in dense stands among shrubs. Eleven gums were good with spreading crowns and excellent vigor; nine were poor and either leaning or one-sided with significant branch dieback.

**Photo 3** (left). River gum #4480 (center) was growing in a crowded grove of gums near the existing cemetery.

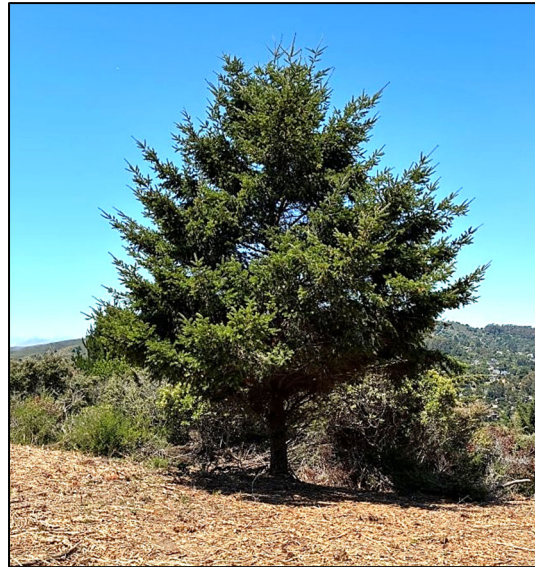
**Photo 4** (below). Douglas-fir #4320 was a young tree in good condition.

Thirteen of 18 Douglas-firs were in good condition with vigorous dense foliage and typical upright pyramidal form (Photo 4). Five were fair with some dieback, growing crowded among dense shrubs. Diameters were 7 to 31 inches.

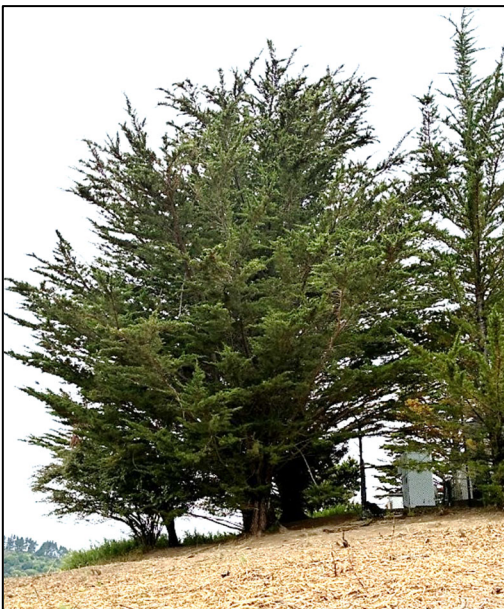
Twelve Monterey cypress were in either good (7 trees) or fair (5 trees) condition (Photo 5). Tree #4080 was poor, located below transmission equipment near the top of the hillside. Stem diameters ranged from 11 to 55 inches.

**Photo 5.** Monterey cypress #4072 was growing near the top of the hillside.
