**GEOLOGIC AND GEOTECHNICAL FEASIBILITY EVALUATION
NEW RESIDENTIAL SUBDIVISION
11798 HIGHWAY ONE
APN #119-050-04, 119-050-09, 119-140-03 and 119-140-09
POINT REYES STATION, CALIFORNIA**

November 6, 2024

Job No. 3614.001

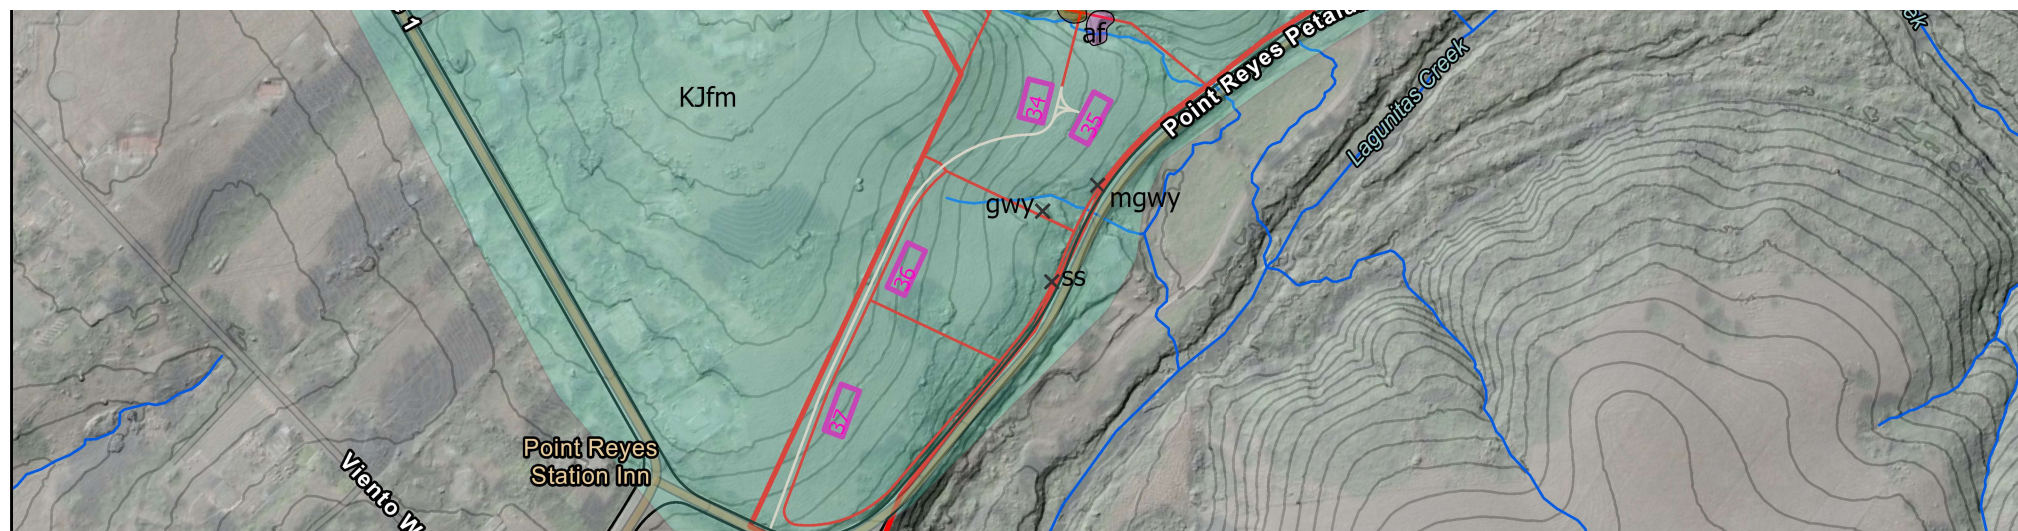
**FIGURE
2**

As shown on Figure 2, geologic mapping performed during our reconnaissance indicates the site is underlain by Franciscan “melange”, which at the site consists primarily of very hard, very strong meta-graywacke. These rocks are typically dark gray with variable quartz and calcite veins and form prominent outcrops around the property as indicated on Figure 2. Rarer outcrops of moderately hard tan sandstone and dark gray shale were noted in the northeastern part of the site, and one outcrop of very hard meta-chert was observed in the south-central portion of the property.

Excavations for new foundations, utilities and other improvements in areas mapped as Franciscan Complex bedrock (Map Unit Fm as shown on Figure 2) are likely to encounter 1- to 3-feet of medium-dense silty sandy residual soils over hard and strong sandstone bedrock. In areas mapped as landslides, similar bedrock is likely to be overlain by thicker deposits of unconsolidated silty to sandy landslide debris. It is anticipated that shallow excavations can likely be accomplished with “traditional” equipment, such as medium to large excavators and dozers. Where zones of especially hard/strong rock are encountered, or where excavations deeper than 3- to 4-feet are planned, specialized hard rock excavation techniques and equipment, such as jackhammers and hydraulic breakers, may be required.

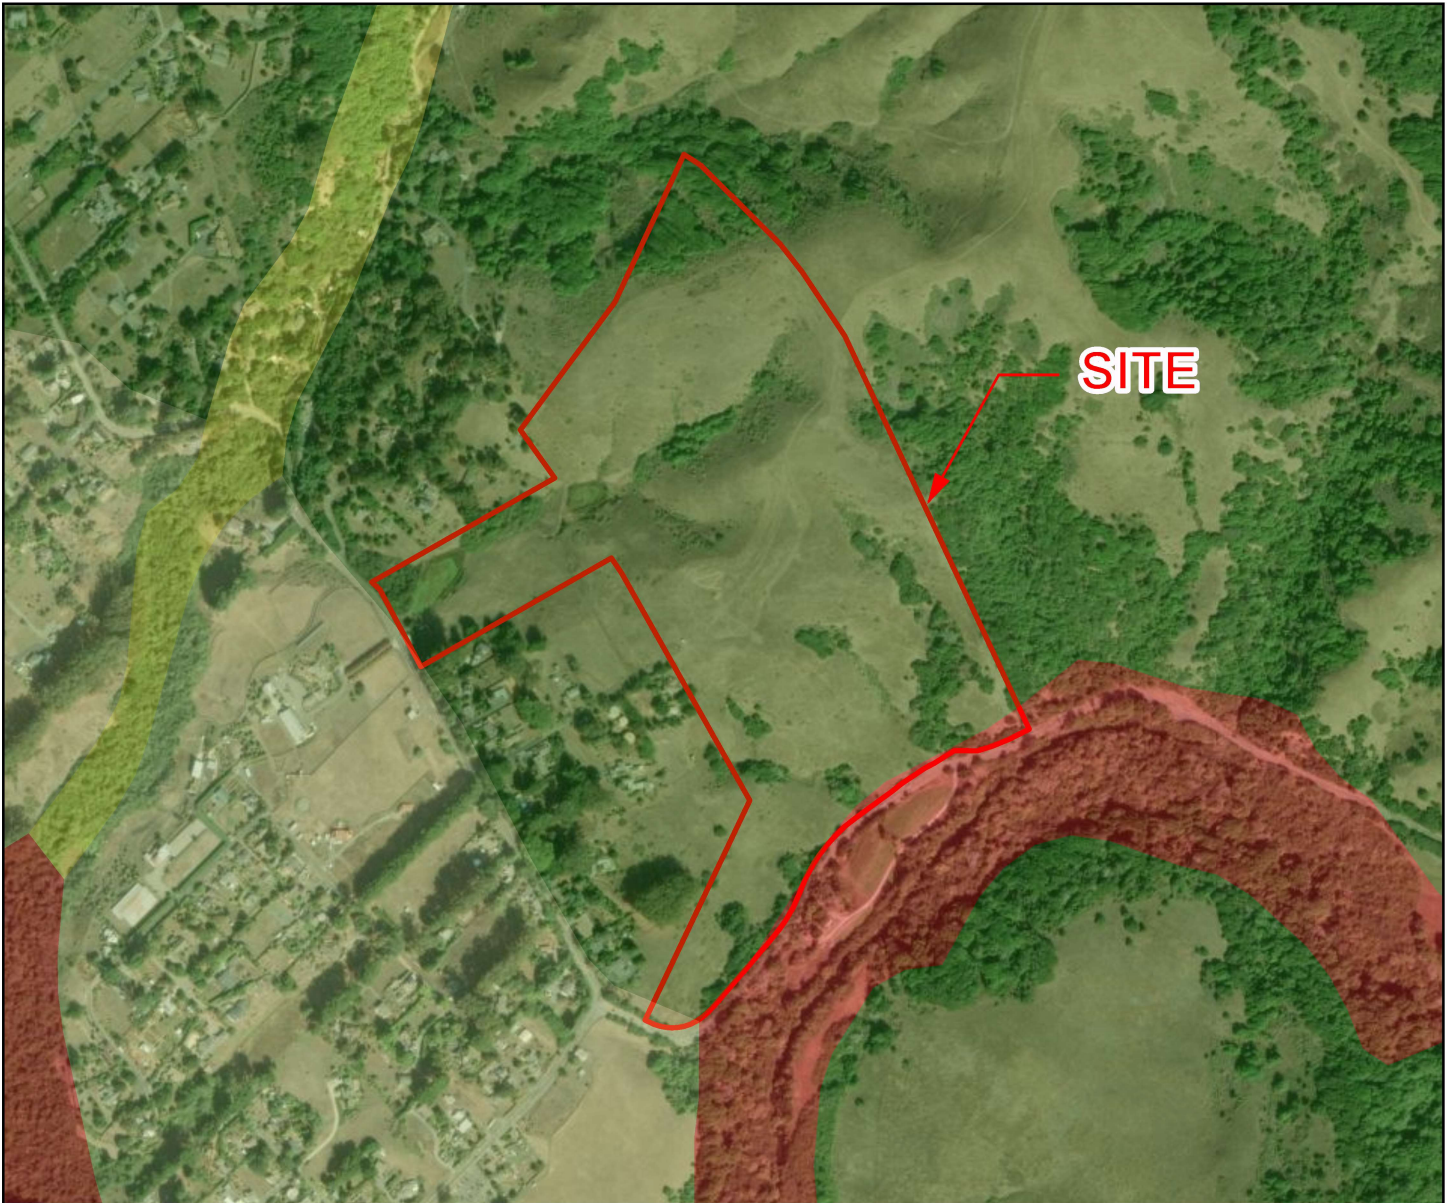
**FIGURE
 8**

Liquefaction refers to the sudden, temporary loss of soil strength during strong ground shaking. The strength loss occurs as a result of the build-up of excess pore water pressures and subsequent reduction of effective stress. While liquefaction most commonly occurs in saturated, loose, granular deposits, recent studies indicate that it can also occur in materials with relatively high fines content provided the fines exhibit lower plasticity. The effects of liquefaction can vary from cyclic softening of clays, resulting in limited strain potential, to post-liquefaction settlements and lateral ground movements as a result of lurching or lateral spreading. Regional mapping (USGS, 2006) indicates the site lies in a zone of “very low” liquefaction potential, as shown on Figure 8.

In general, subsurface conditions throughout the site are anticipated to consist of variable silty to sandy soils over relatively shallow weathered bedrock. Although minor alluvial deposits may exist at silted-in agricultural ponds or the mouths of the incised channels, they are probably thin and we judge the likelihood of liquefaction there is relatively low. We judge that, were it to occur, the risk of damage to improvements due to liquefaction is low.
