***Aquatic Resources Delineation Report
PRS Vacant Lots Subdivision by Cui
Point Reyes Station, Marin County, California***

June 2024

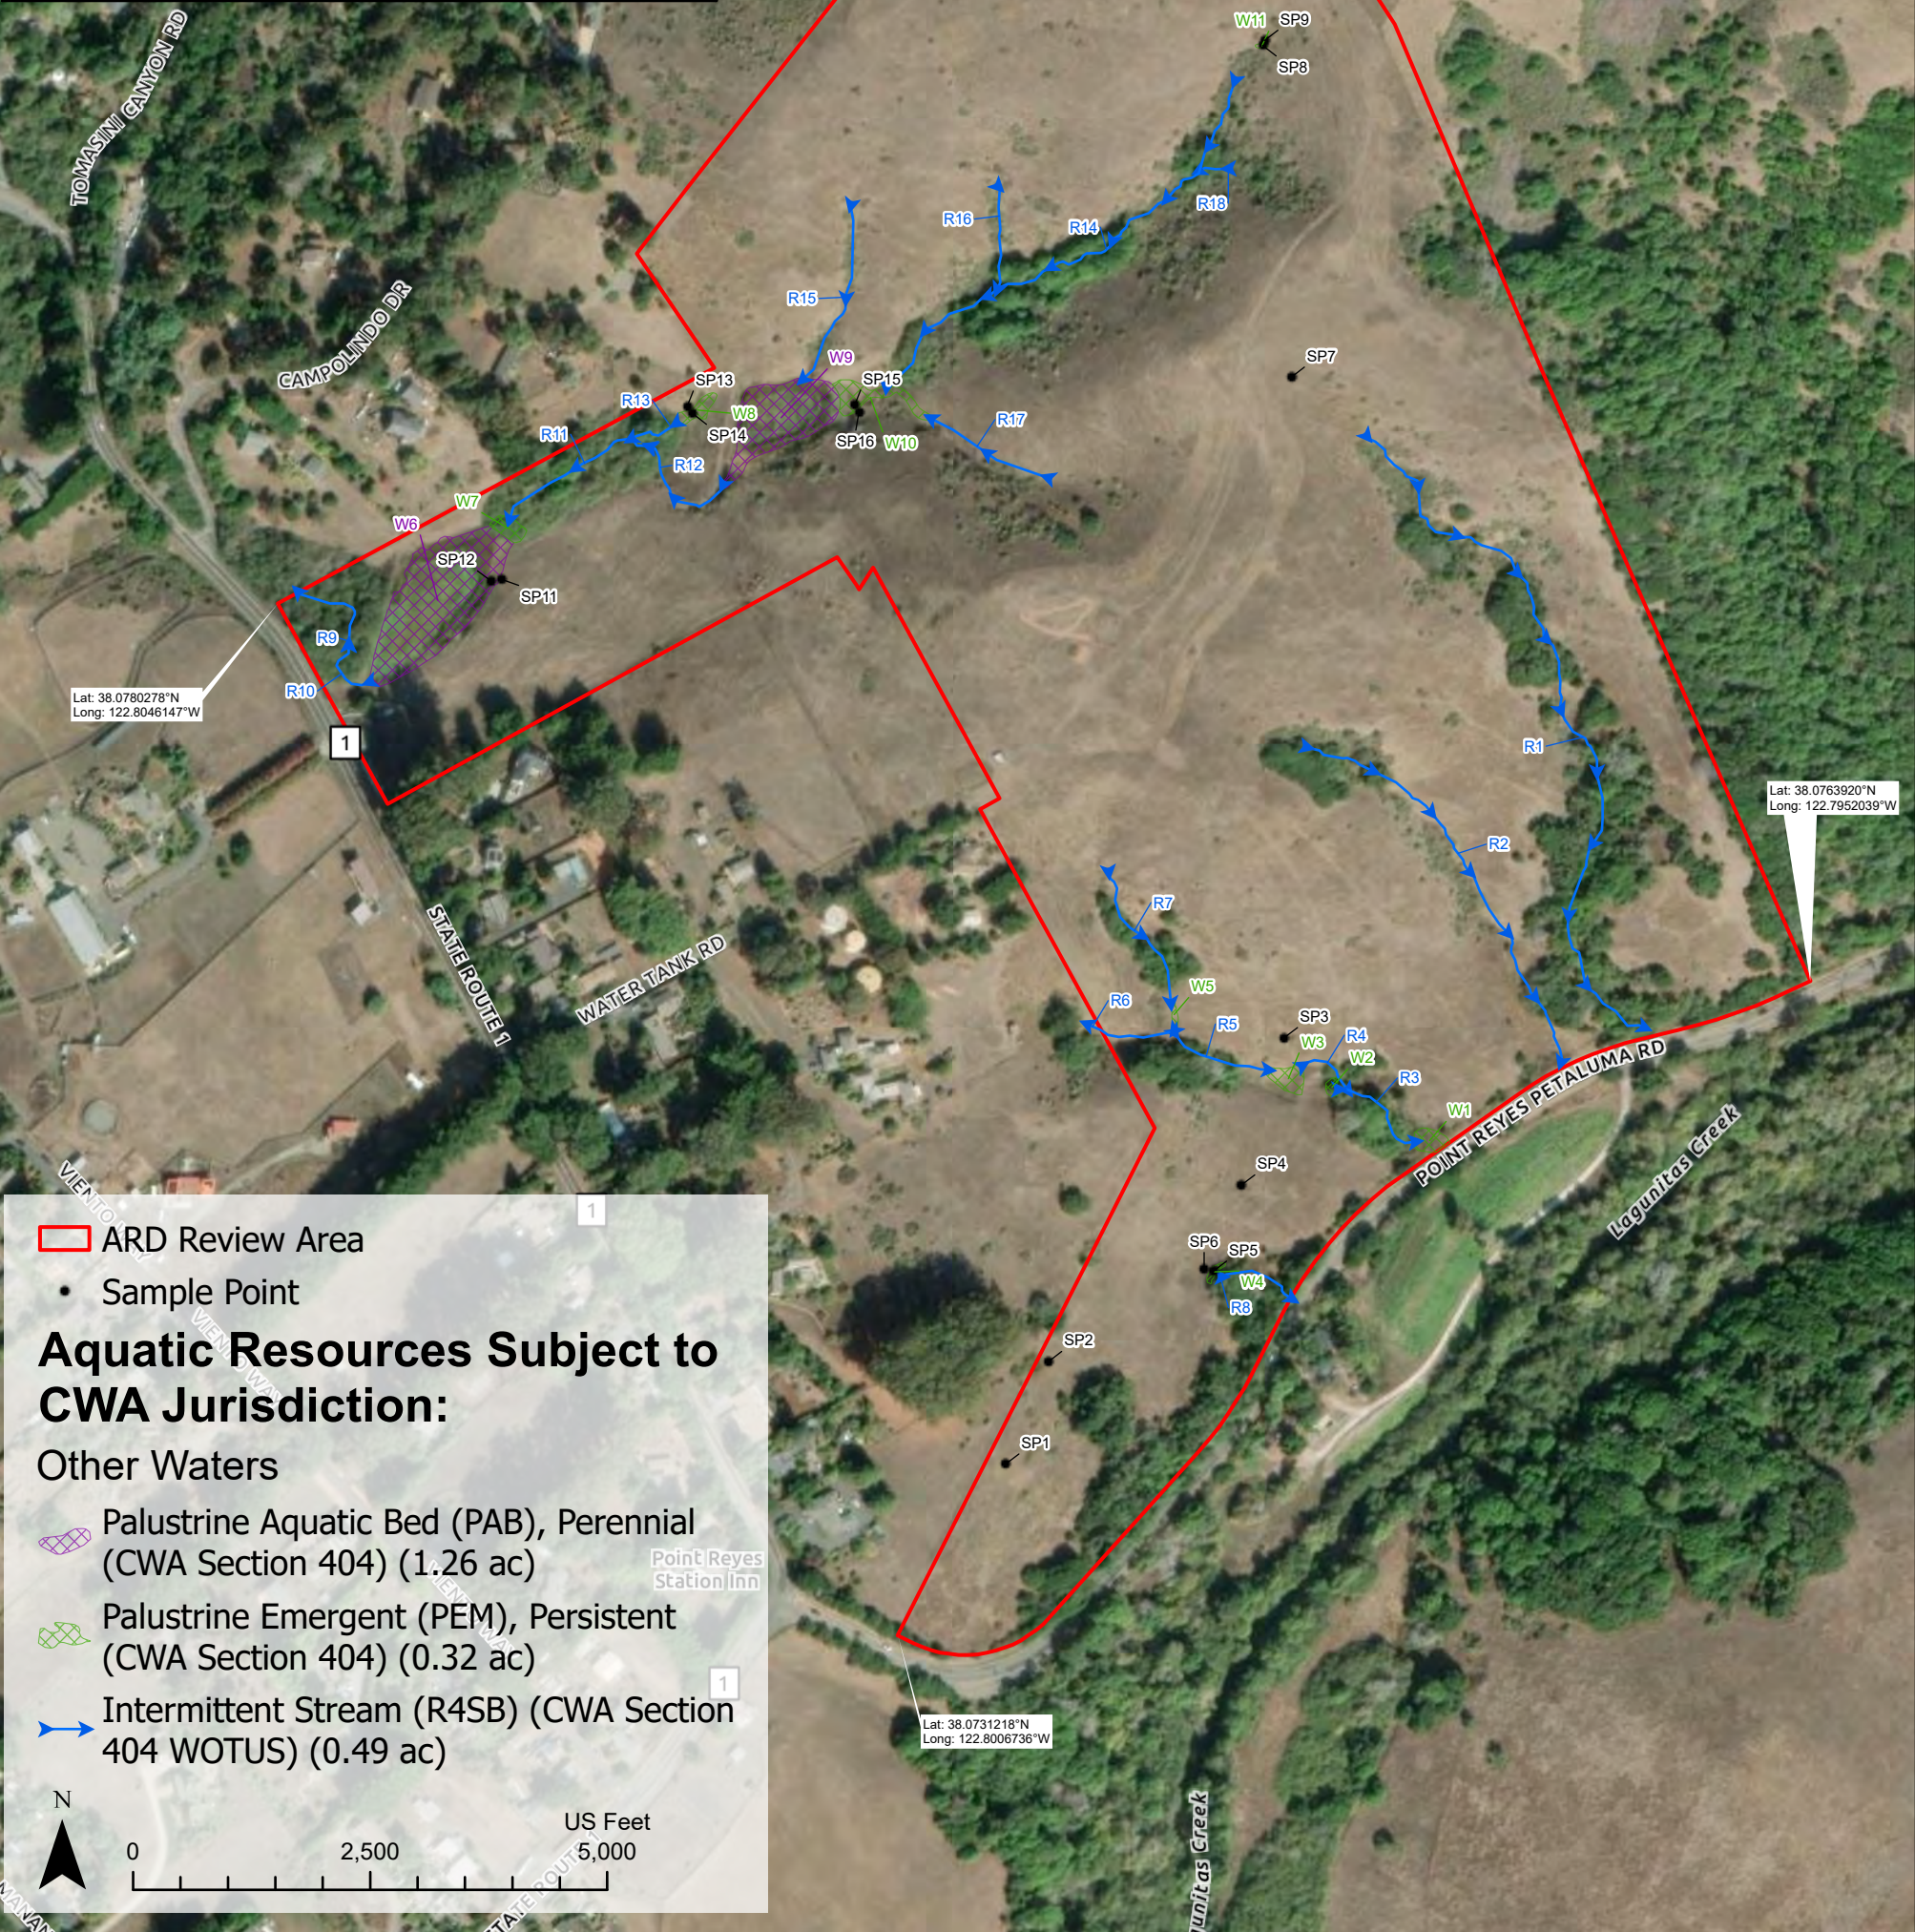
Figure 6. Aquatic Resource Delineation

Stream #	OHWM	Length (ft)	Wetland #	Acreage
R1	6	1332	W1	0.05
R2	4	767	W2	0.01
R3	2	185	W3	0.05
R4	2	109	W4	0.01
R5	2	186	W5	0.01
R6	2	160	W6	0.82
R7	2	274	W7	0.04
R8	2	144	W8	0.04
R9	4	171	W9	0.44
R10	2	121	W10	0.1
R11	4	306	W11	0
R12	2	213		
R13	4	92		
R14	4	894		
R15	2	333		
R16	2	184		
R17	3	233		
R18	2	54

Aquatic resources in the form of wetlands and tributaries (streams with an OHWM) were found within the Review Area. In summary, approximately 1.57 acres of wetland and approximately 5,758 linear feet of intermittent streams were delineated within the Review Area. Appendix A, Figure 6 shows the extent and location of aquatic resources identified and delineated.

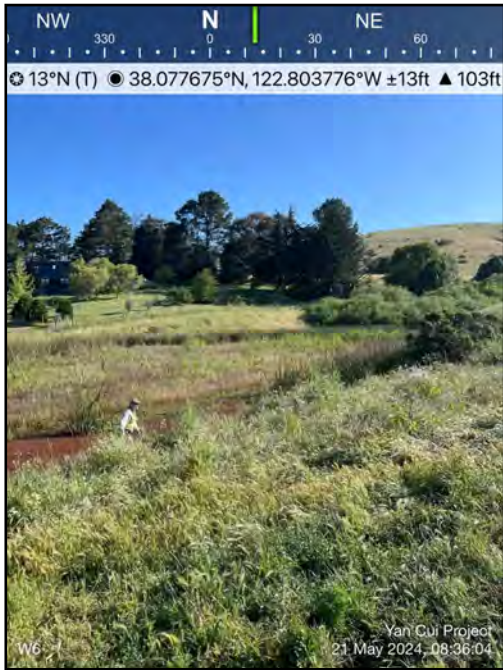
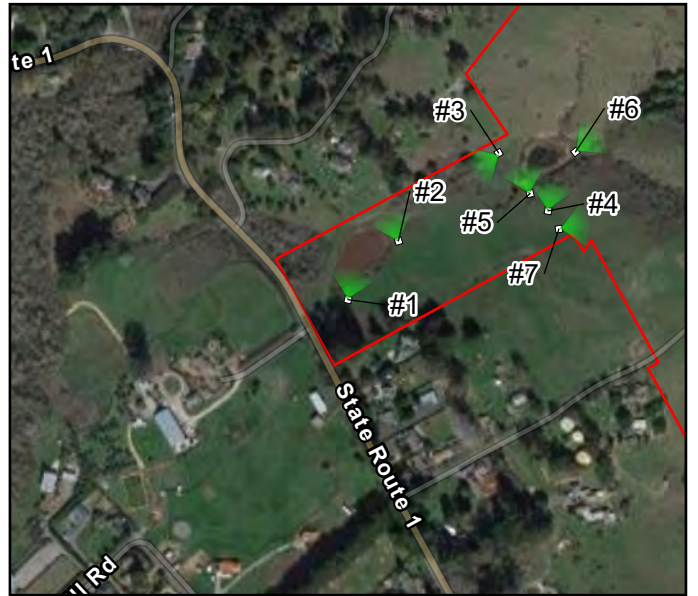
Photo ID: 1

Photo Description: W6

Aquatic resources W6 and W9 are deeper, perennial, wetlands with root vegetation and classified as palustrine aquatic bed habitat. The aquatic resource on the Review Area is perennial in nature and dominated around the edges by bulrush (*Schoenoplectus americanus*), Harding grass (*Phalaris aquatica*) and spreading rush (*Juncus patens*), and within the majority of the pond by duckweed and pondweed species and various plants found in pond habitat such as water plantains (*Alisma* spp.), and sedges.

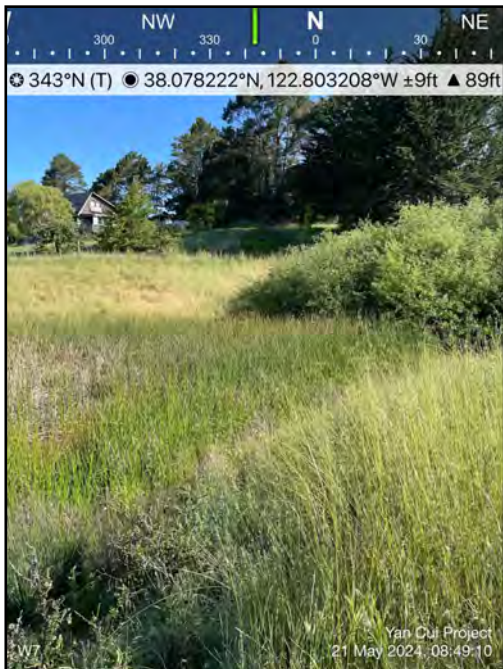
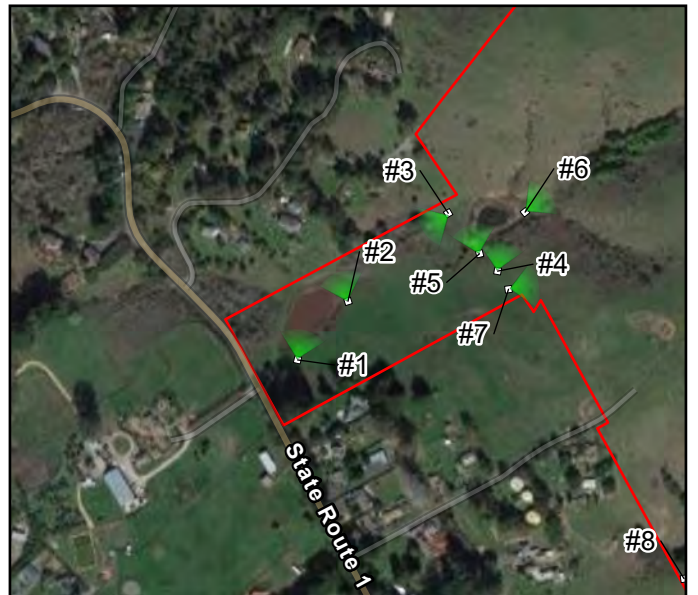
Photo ID: 2

Photo Description: W7

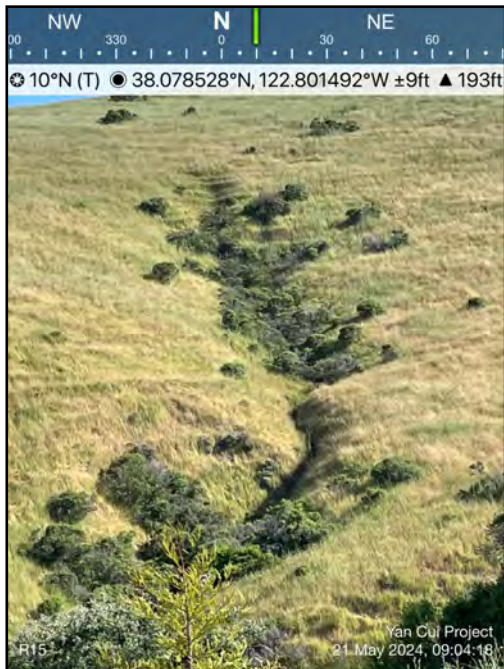
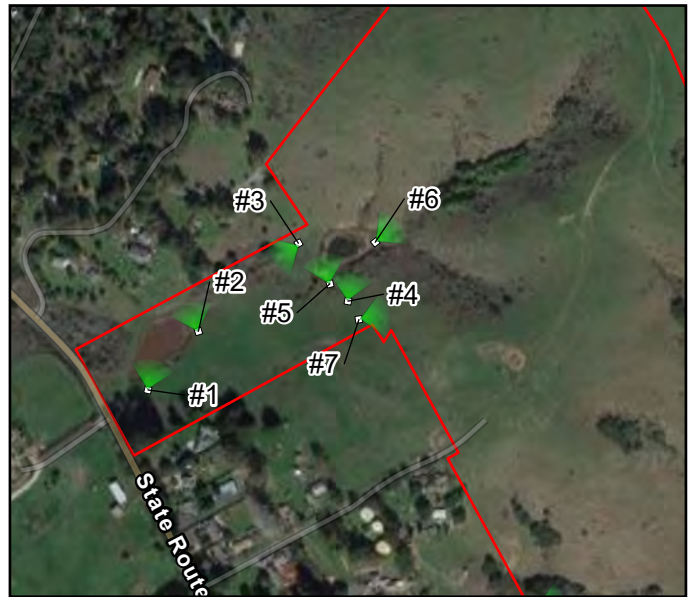
Photo ID: 4

Photo Description: R15

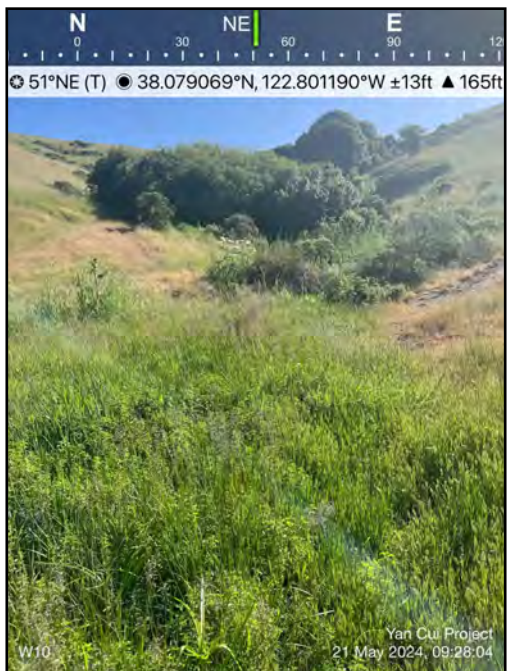
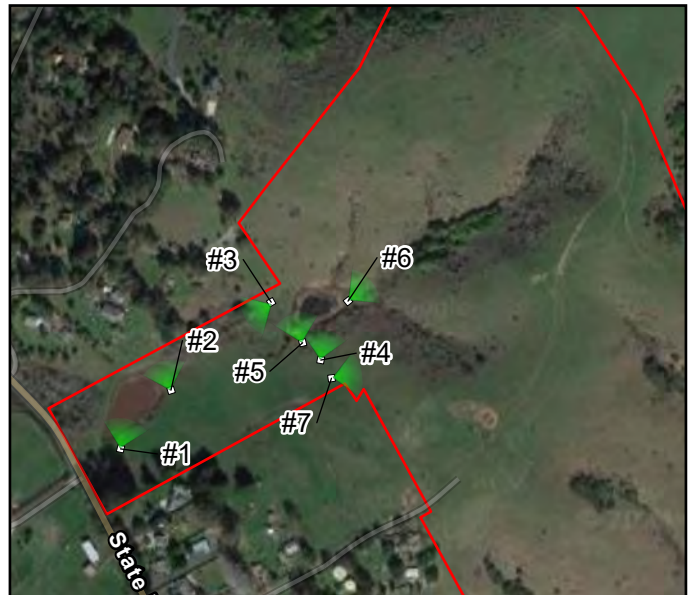
Photo ID: 6

Photo Description: W10

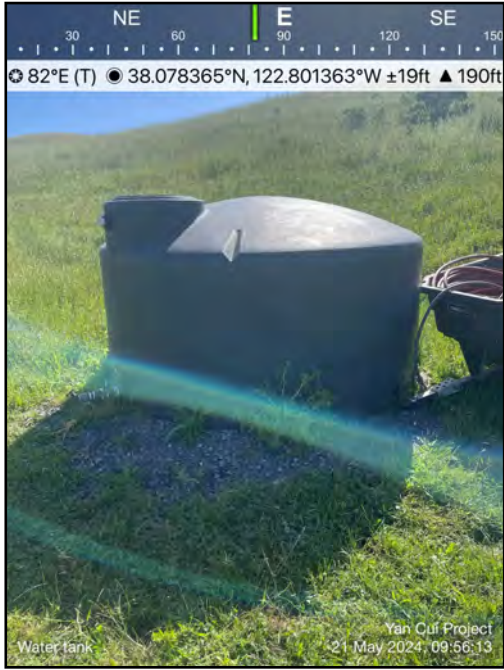
Photo ID: 7
Photo Description: Water tank

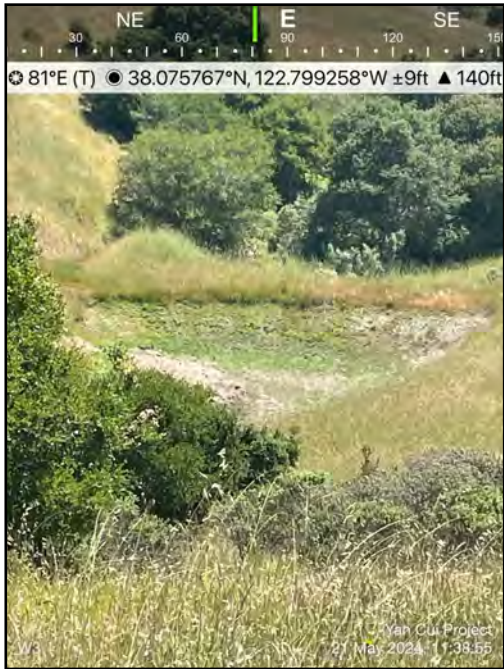
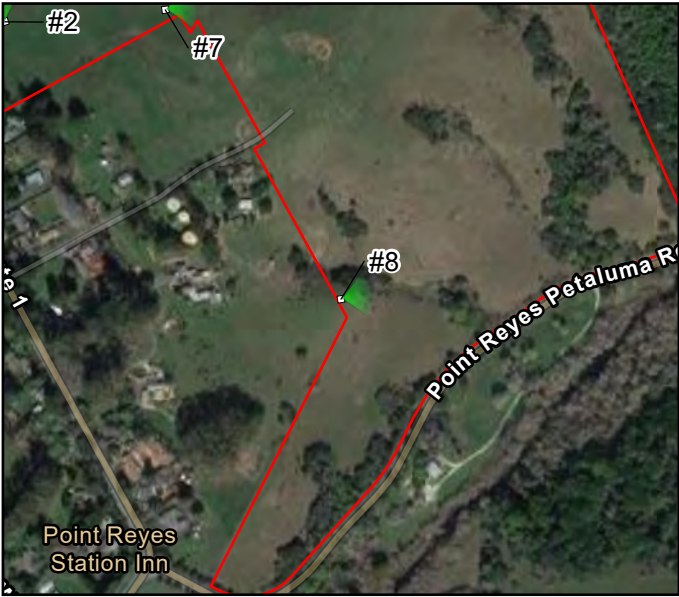
Photo ID: 8
Photo Description: W3
