**Appendix C:**  
**Biological Resources Supporting Information**

## Biological Resources Assessment Oak Hill Apartments Project Marin County, California

# Preliminary Arborist Report

Oak Hill Apartments  
Marin County, CA

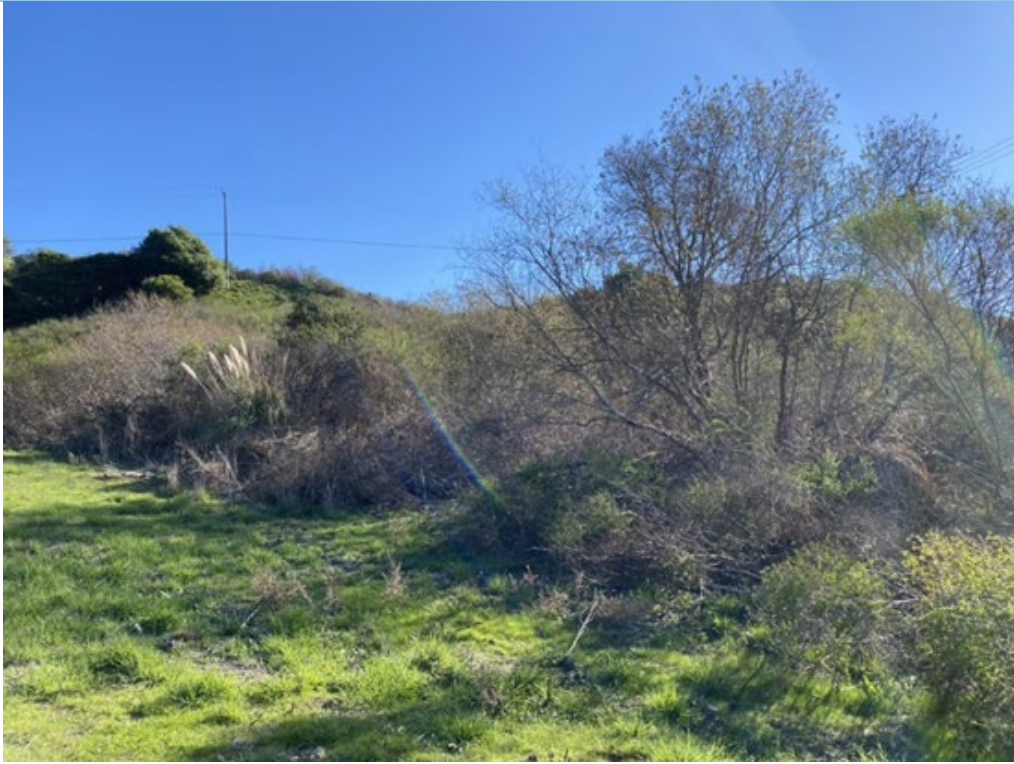
Photograph 1: Looking east, riparian willows along drainage channel segment 1-5.

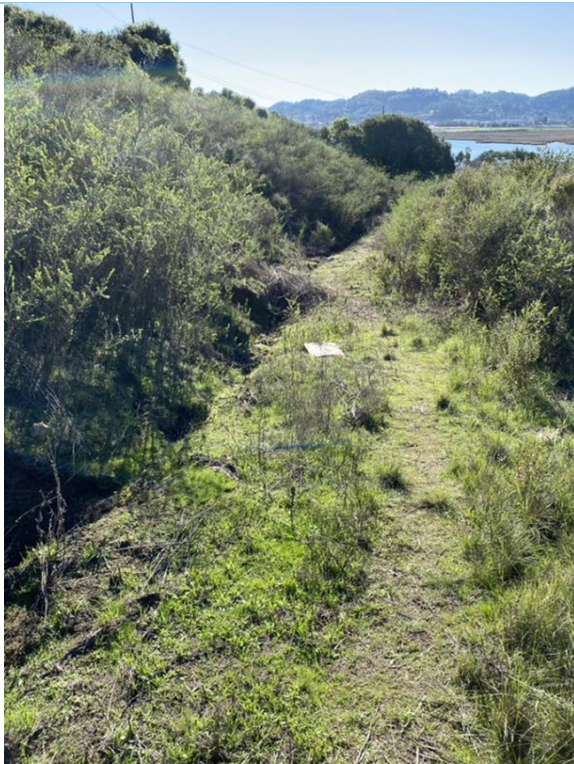
Photograph 6: Constructed diversion ditch (drainage segment 1-4) along access road (left side of photograph). Photo facing southwest.

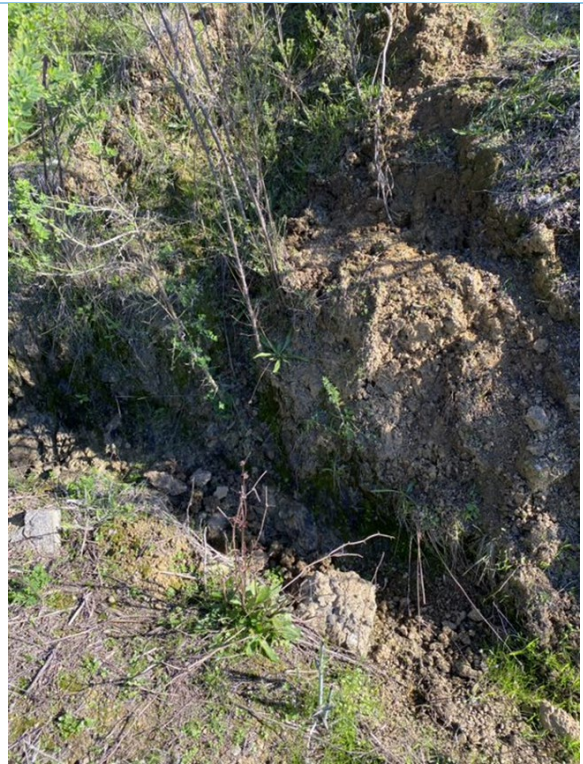
Photograph 7: Scour in Drainage Segment 1-4.

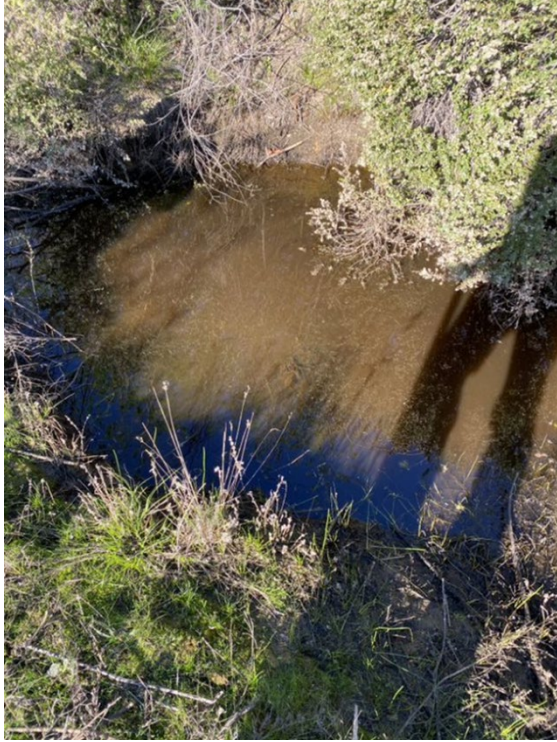
Photograph 8: Standing water in constructed diversion ditch parallel to the eastern slope (drainage segment 1-3). Facing northeast.

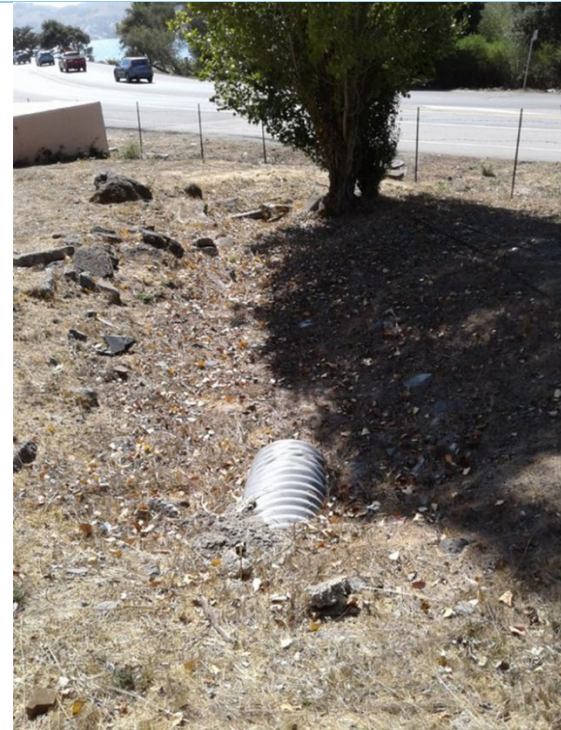
Photograph 11: Culvert draining into Segment 5-3 facing south towards Sir Francis Drake Boulevard

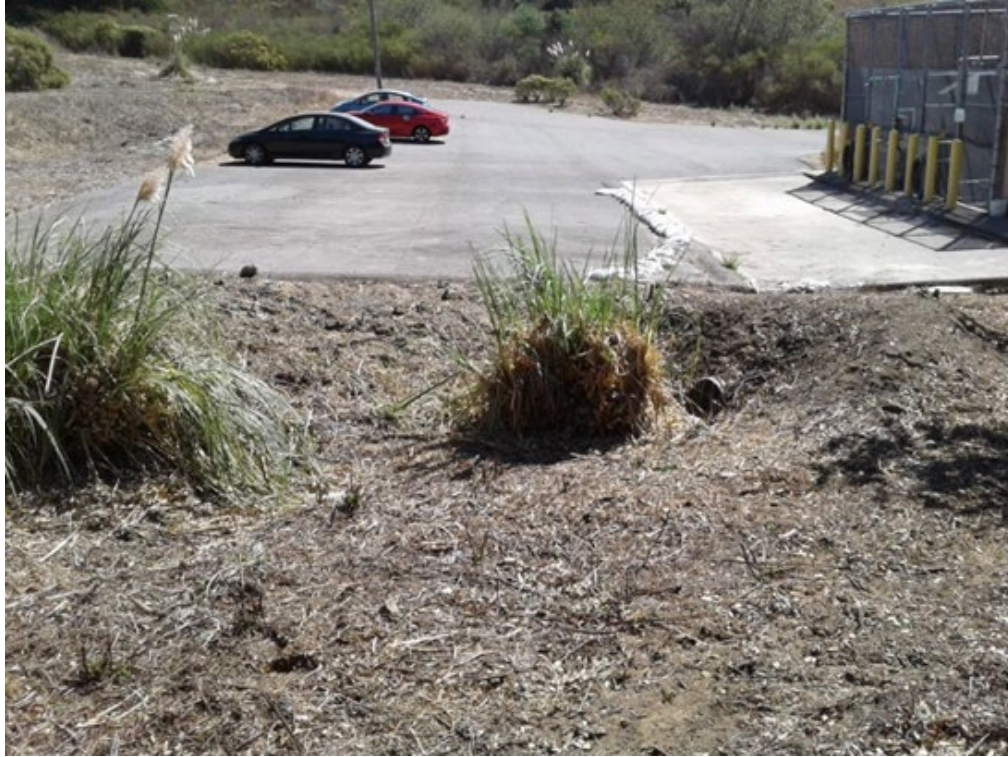
Photograph 12: Culvert at bottom of Drainage Segment 5-1.

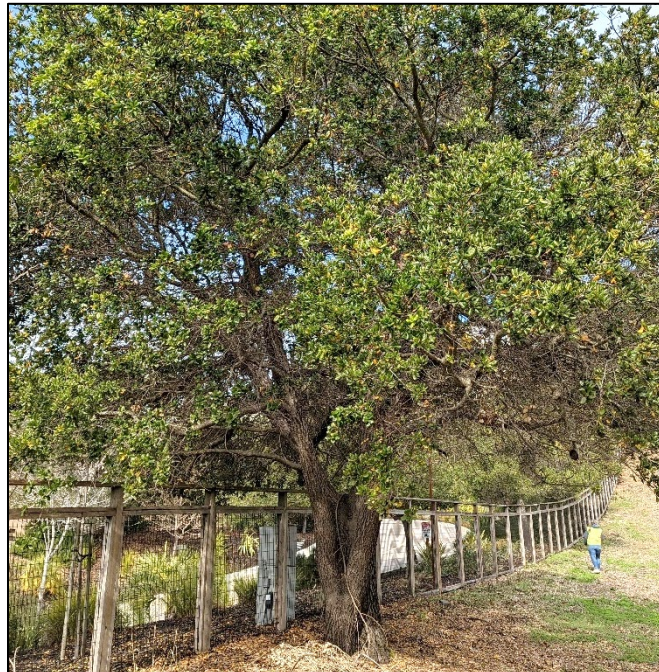
Structural issues were common among the oaks including narrow branch unions with included bark, slight to severe lean, and multi-stems that arose close to the ground. None of the oaks had good structure free of defects (Photo 1).

**Photo 1:** Looking north along the property boundary at coast live oak #305. This tree had fused codominant stems arising from the base. It also had multiple attachments arising from 5' on its northern stem.

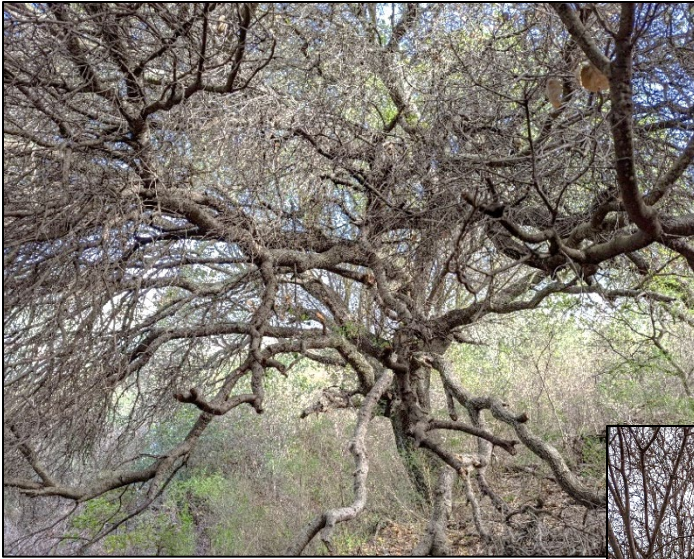
While most oaks had vigorous canopies, trees #305, #312, and #314 had thinning canopies with some leaf chlorosis. Tree #315 was in poor condition with a thinning canopy and twig and branch dieback. It had significant decayed and dead wood in the lower canopy that was laying directly on the ground (Photo 2). The tree had sunken areas in the bark and very little visible root flare (Photo 3).

**Photo 2 (left):** Looking north at coast live oak #315. Most of the canopy was in decline with many limbs sitting directly on the ground and decaying.

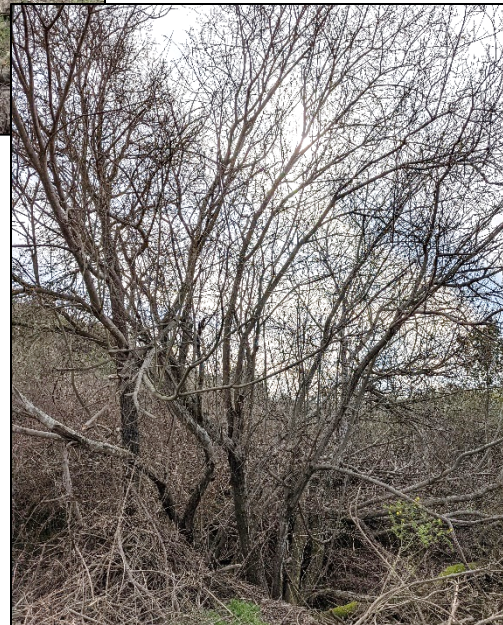
**Photo 3 (below):** Looking southeast at arroyo willow #302. The tree is surrounded by branches and twigs from past failures.

Arroyo willows #301 and #302 were located in a creek channel on the southeastern end of the property, closer to East Sir Francis Drake Blvd. Tree #301 was located directly in front of a culvert. Both trees had codominant stems or multiple attachments which arose between the ground and 2 feet. The trees were semi-mature in development with stems that ranged in size from 5 to 9 inches. They were in poor condition with mostly dead branches and twigs. Tree #302 had multiple failed stems and branches (Photo 3).

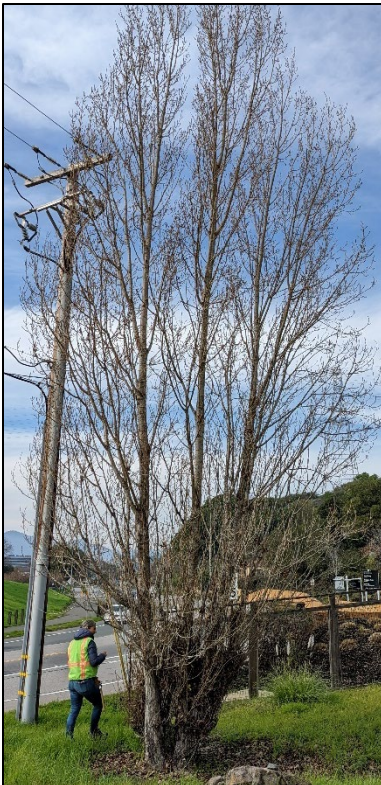
Lombardy poplar #304 was planted at the southwest corner of the property closest to East Sir Francis Drake Blvd. The tree was semi-mature in development and had multiple attachments which ranged in diameter from 1 to 9 inches. Codominant stems arose from the base and split into multiple attachments at 3 feet (Photo 4).

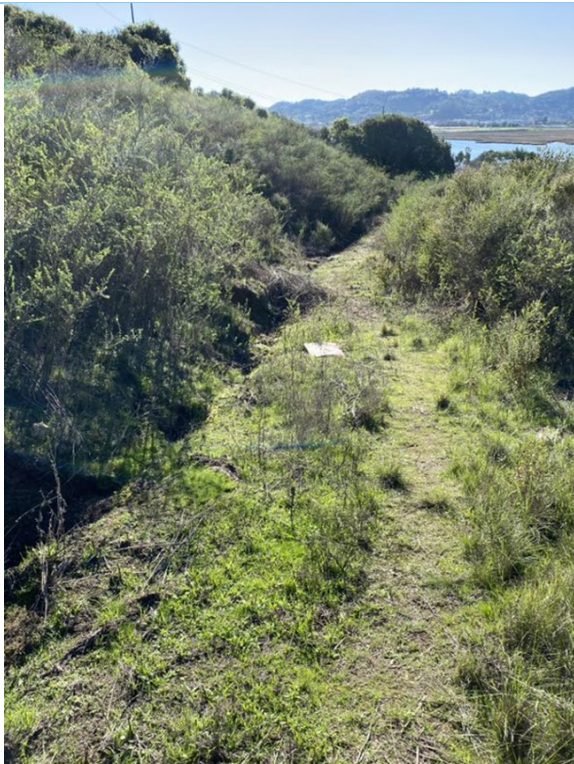
Photograph 6: Constructed diversion ditch (drainage segment 1-4) along access road (left side of photograph). Photo facing southwest.

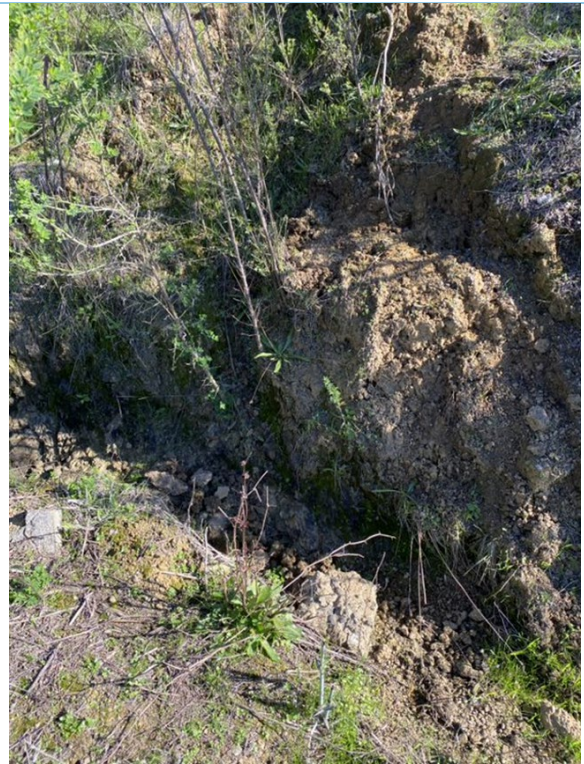
Photograph 7: Scour in Drainage Segment 1-4.

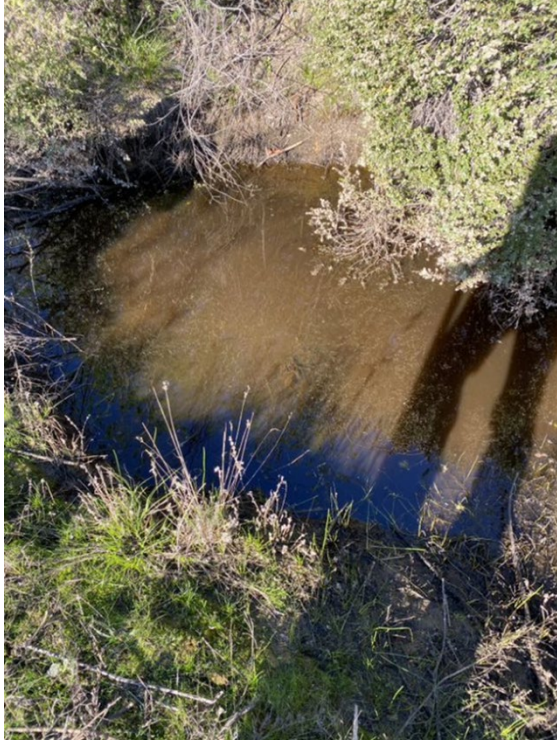
Photograph 8: Standing water in constructed diversion ditch parallel to the eastern slope (drainage segment 1-3). Facing northeast.

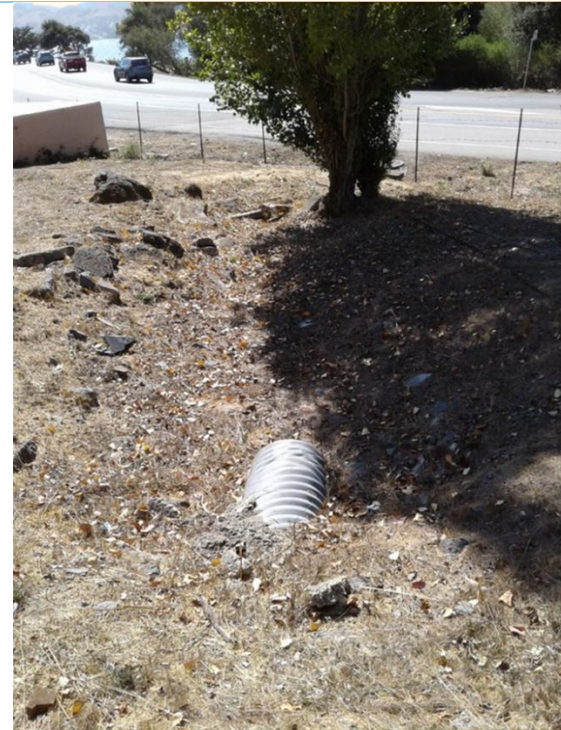
Photograph 11: Culvert draining into Segment 5-3 facing south towards Sir Francis Drake Boulevard

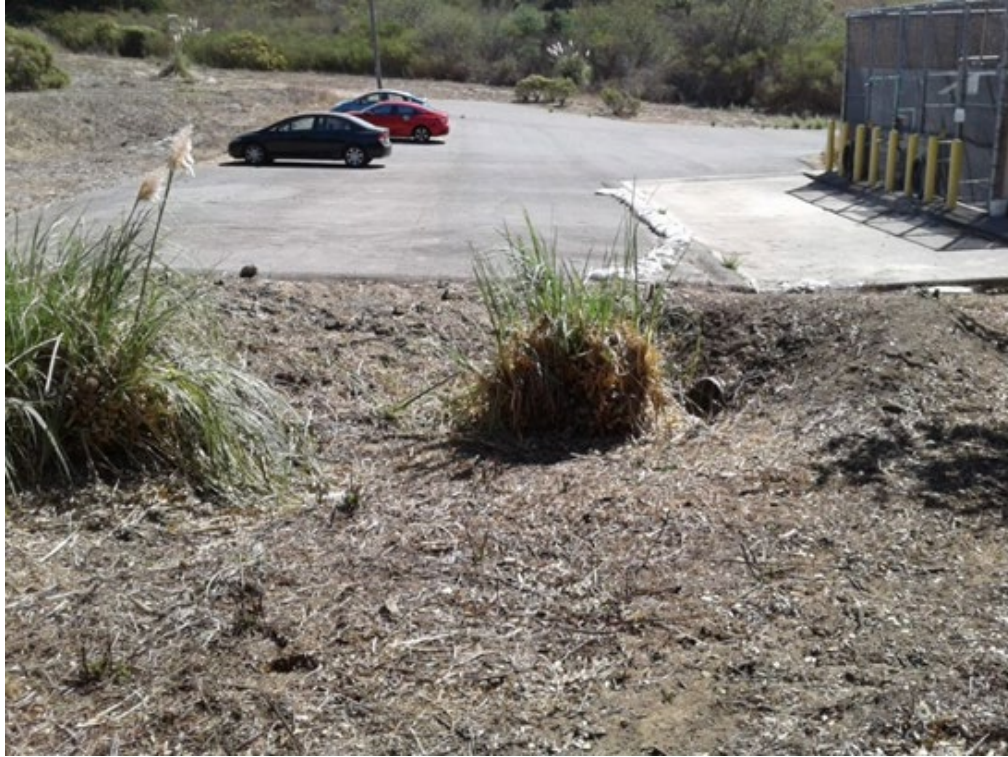
Photograph 12: Culvert at bottom of Drainage Segment 5-1.

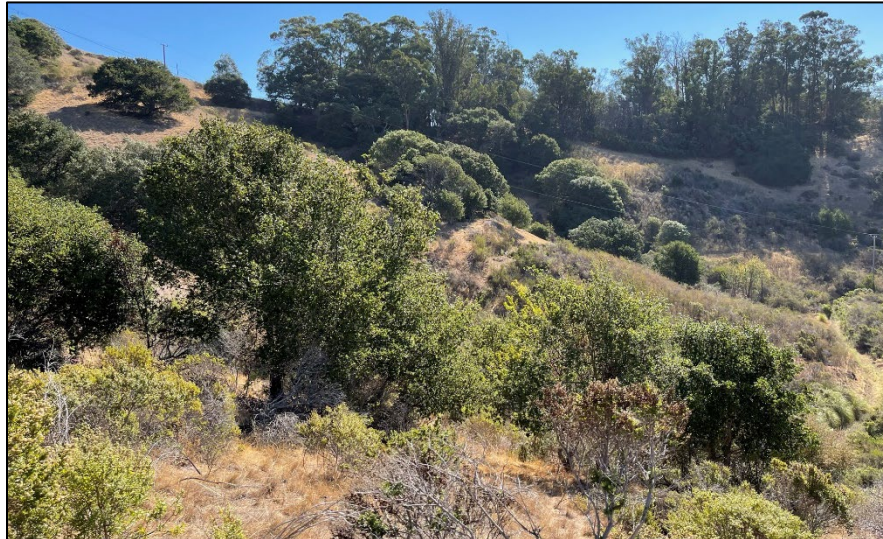
**Photo 1:** Looking northeast at several stands of oaks on the northern edge of the project site. The eucalyptus on the ridgeline were outside of the project boundaries.

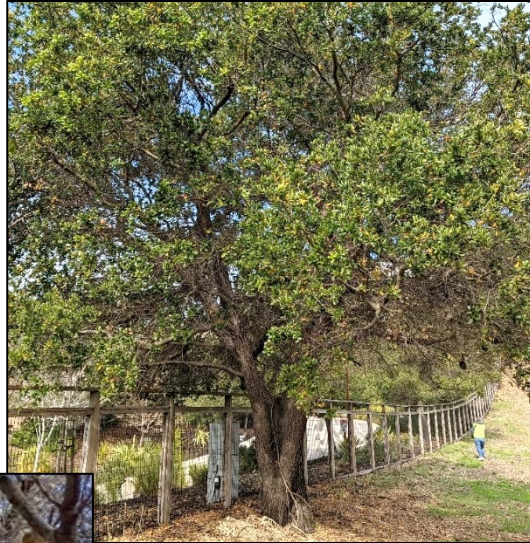
**Photo 1 (above):** Looking north along the property boundary at coast live oak #305. This tree had fused codominant stems arising from the base. It also had multiple attachments arising from 5' on its northern stem.

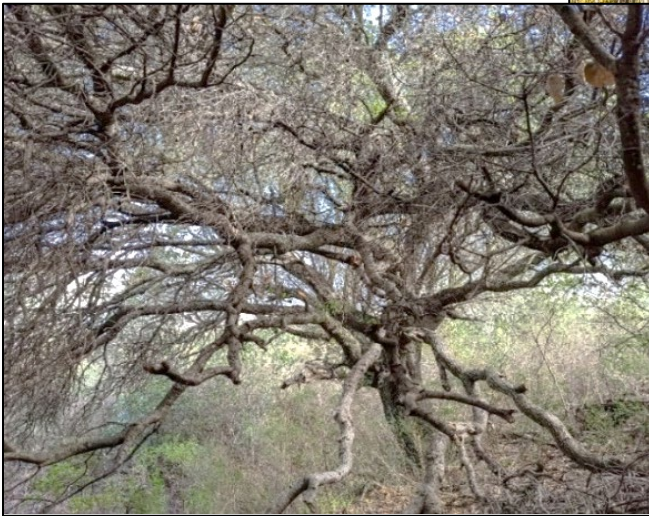
Among the 58 coast live oaks, 23 were in good condition, 32 were in fair condition, and three were poor. Trees ranged in development from young to mature with trunk diameters from 6 to 36 in. Structural issues common among the oaks included narrow branch unions with included bark, slight to severe lean, and multi-stems that arose close to the ground (Photo 2). Tree #148 was the only oak which had good structure and was generally free of defects. Oaks in fair condition tended to have thinning canopies with some leaf chlorosis. Trees in poor condition tended to have significant decay and very thin crowns (Photo 3).

**Photo 2 (left):** Looking north at coast live oak #315. Most of the crown was in decline with many limbs sitting directly on the ground and decaying.

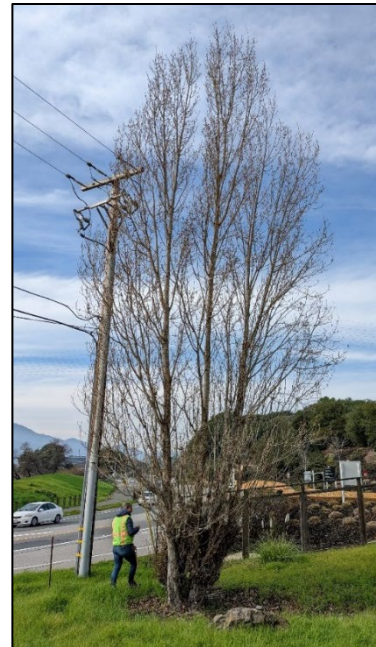
Lombardy poplar #304 was planted at the southwest corner of the property closest to East Sir Francis Drake Blvd. The tree was semi-mature in development and had multiple attachments which ranged in diameter from 1 to 9 in. Codominant stems arose at the base and split into multiple attachments at 3 ft. (Photo 4).

**Photo 4:** Looking west at Lombardy poplar #304 with East Sir Francis Drake Blvd in the background.
