**PRELIMINARY GEOTECHNICAL INVESTIGATION
SPIRIT GROUP SENIOR HOUSING
70 NORTH KNOLL ROAD
MILL VALLEY, CALIFORNIA**

Job No. 3011.002

**PRELIMINARY GEOTECHNICAL INVESTIGATION
 SPIRIT LIVING GROUP SENIOR HOUSING
 70 NORTH KNOLL ROAD
 MILL VALLEY, CALIFORNIA
 TABLE OF CONTENTS**

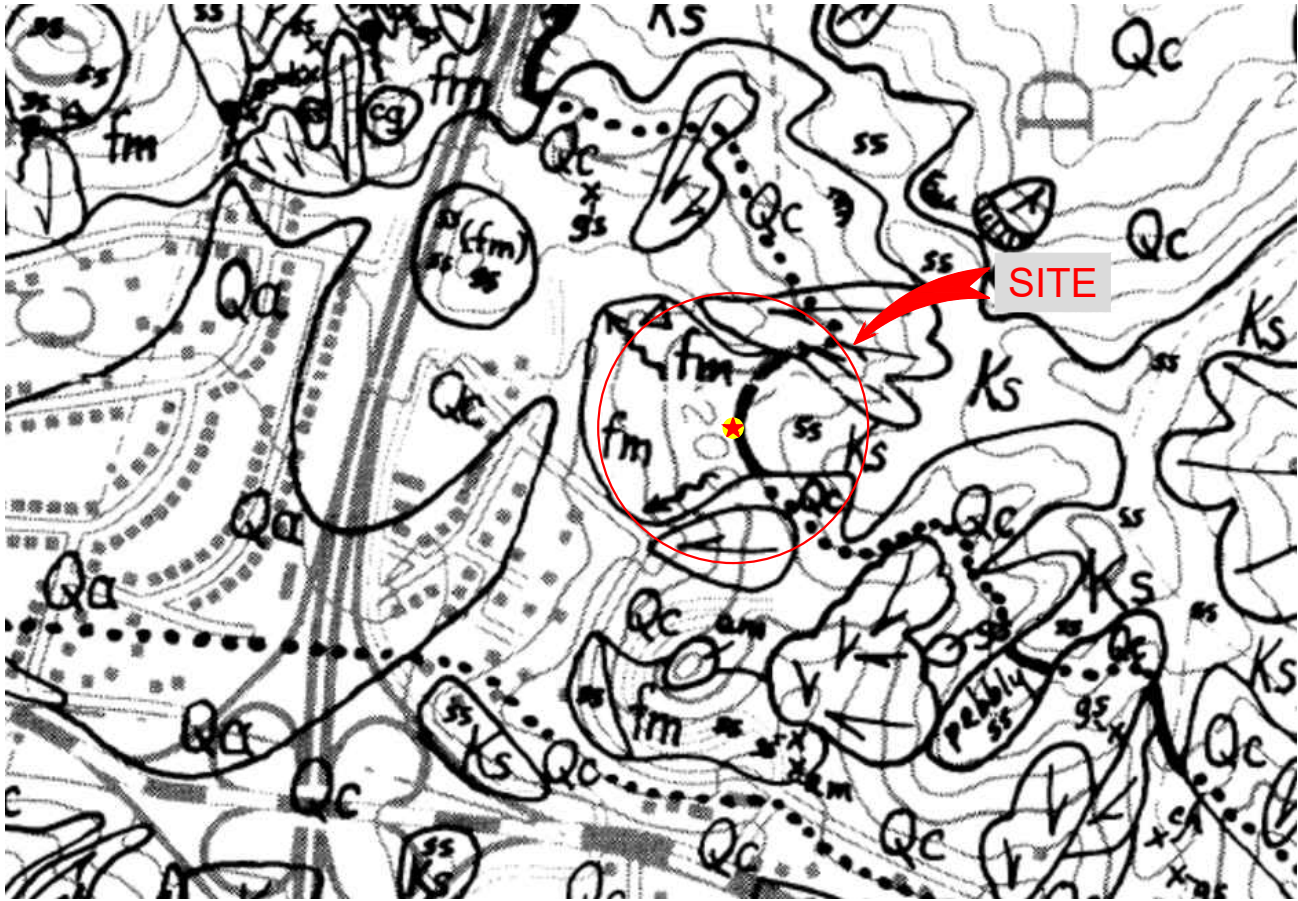
REGIONAL GEOLOGIC MAP

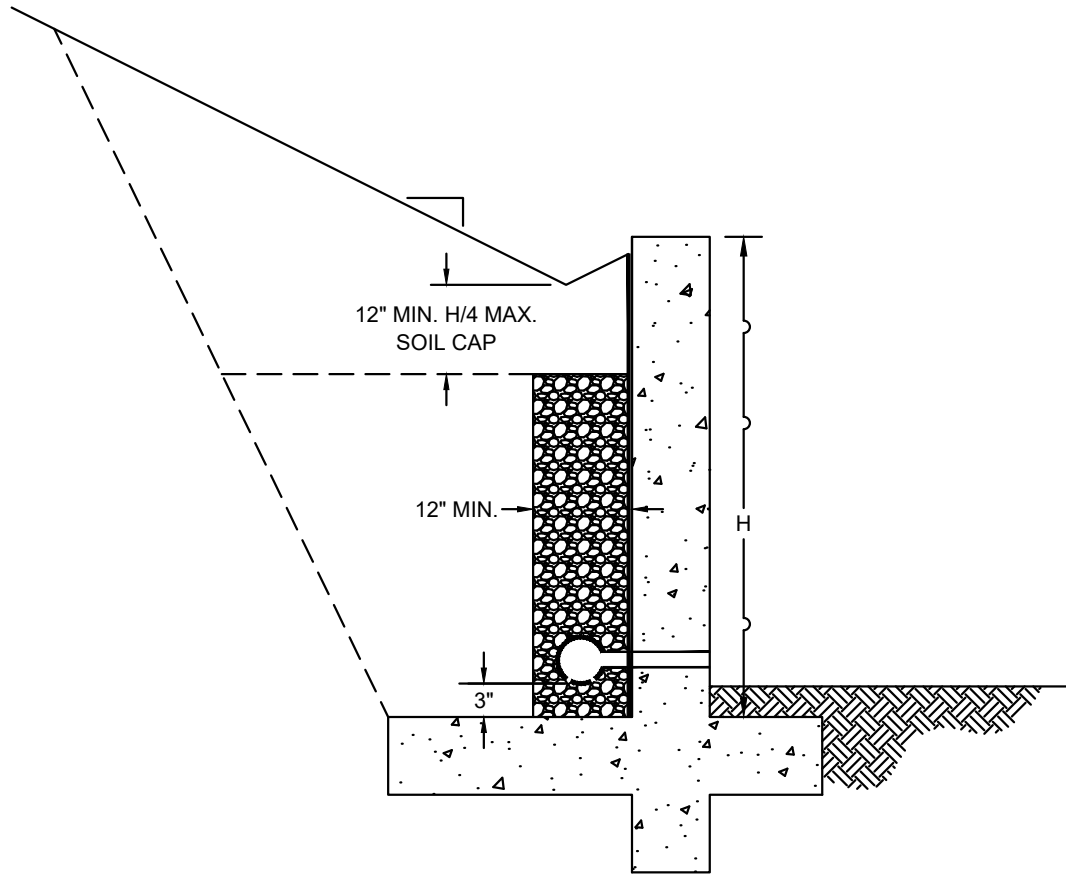
1. Wall drainage should consist of clean, free draining 3/4 inch crushed rock (Class 1B Permeable Material) wrapped in filter fabric (Mirafi 140N or equivalent) or Class 2 Permeable Material. Alternatively, pre-fabricated drainage panels (Miradrain G100N or equivalent), installed per the manufacturers recommendations, may be used in lieu of drain rock and fabric.

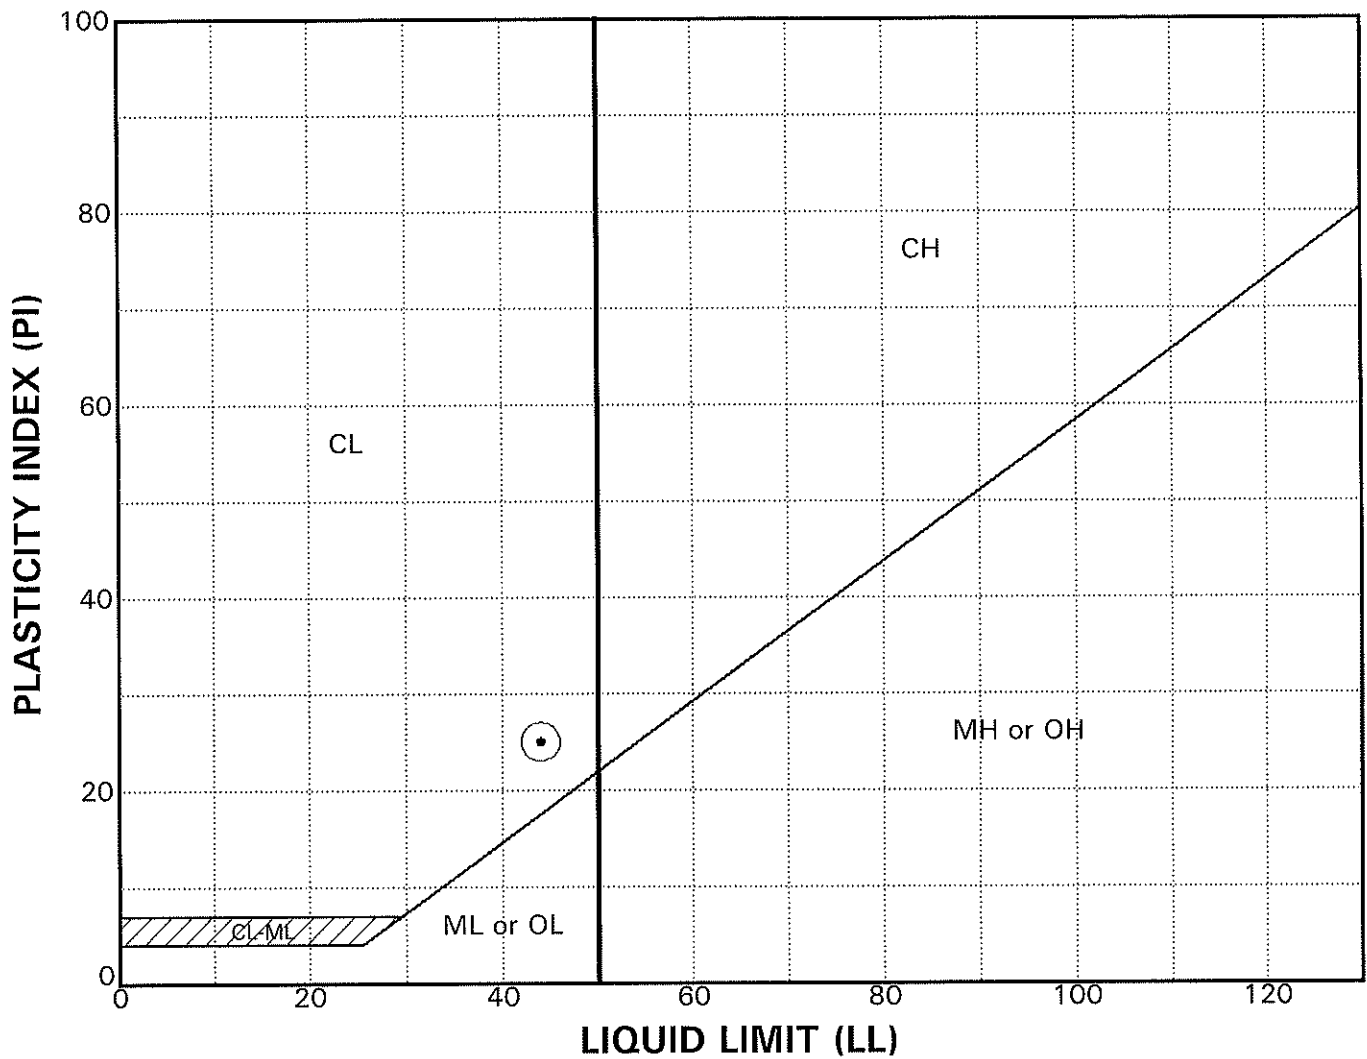
SAMPLE SOURCE	CLASSIFICATION	LIQUID LIMIT (%)	PLASTIC LIMIT (%)	PLASTICITY INDEX (%)	% PASSING #200 SIEVE
⊙ Bor. 1 @ 1.5'	Brown Sandy Clay (CL)	44	19	25
