August 1, 2024
File: 3600.001altr.doc

Re: Geotechnical Investigation
Residential Renovation and Addition
65 Dipsea Road
Stinson Beach, California

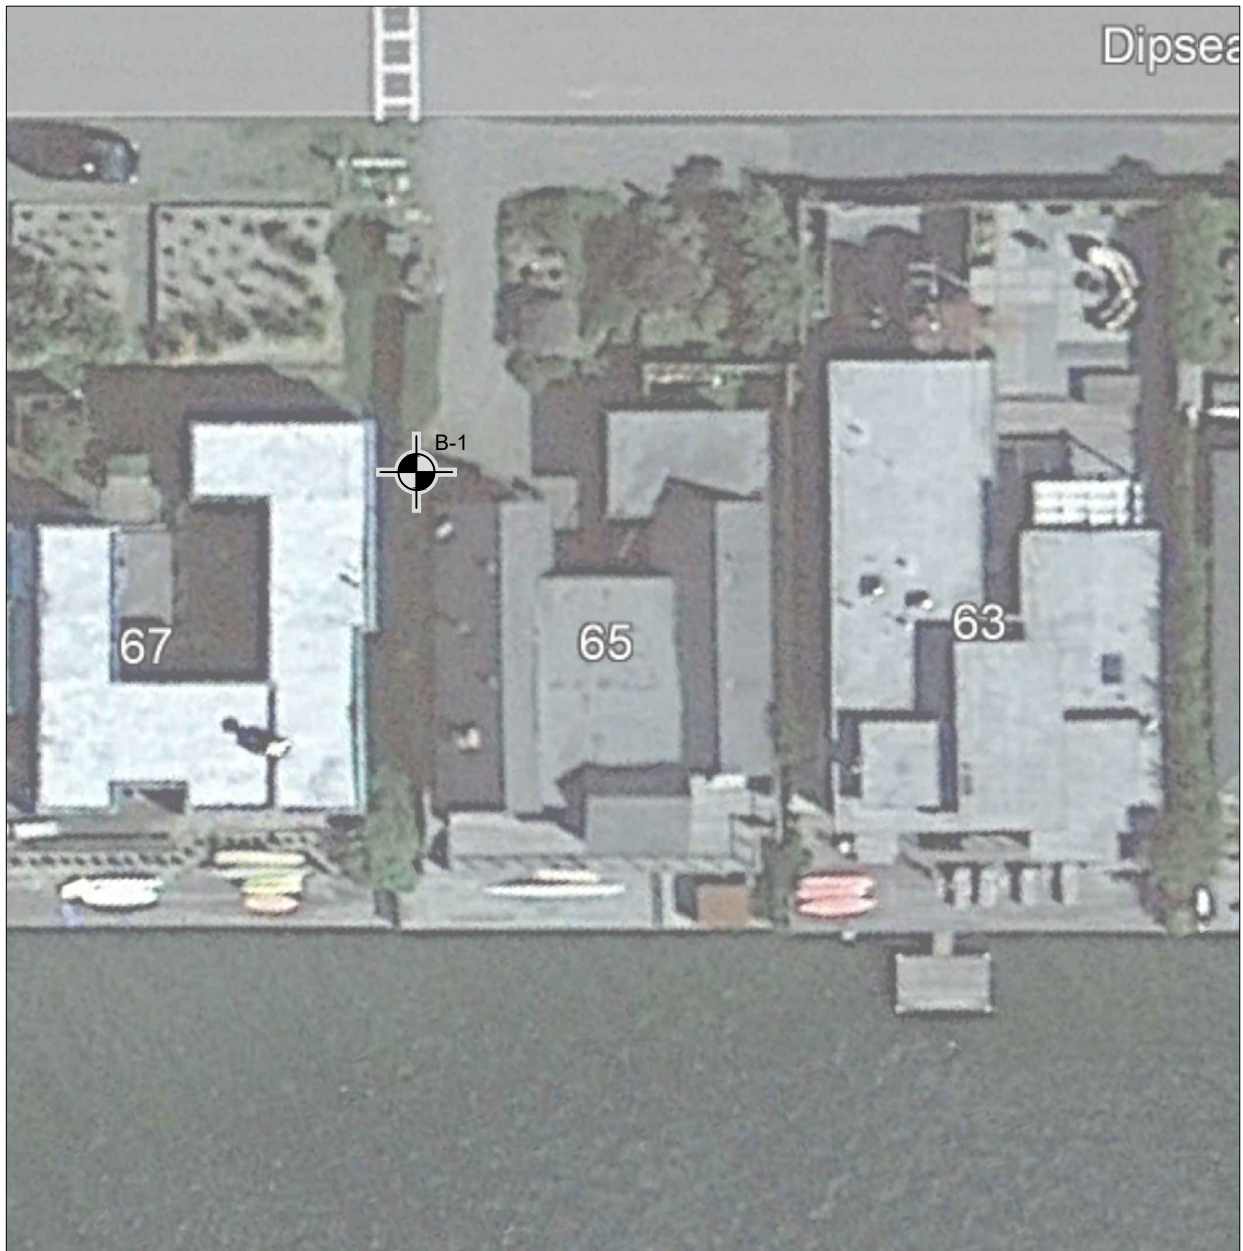
2
 FIGURE

SITE PLAN

Based on review of preliminary plans, we understand the project generally includes removal of a portion of the existing, attached garage, converting it to living space and construction of a new residential addition on the northwest corner of the house. The new addition will create a new accessory dwelling unit. We understand the new addition will utilize shallow spread footings and may use raised wood floors. A new front entry deck will be located between the garage and new addition. A Site Plan showing the extents of the existing improvements is presented on Figure 2.

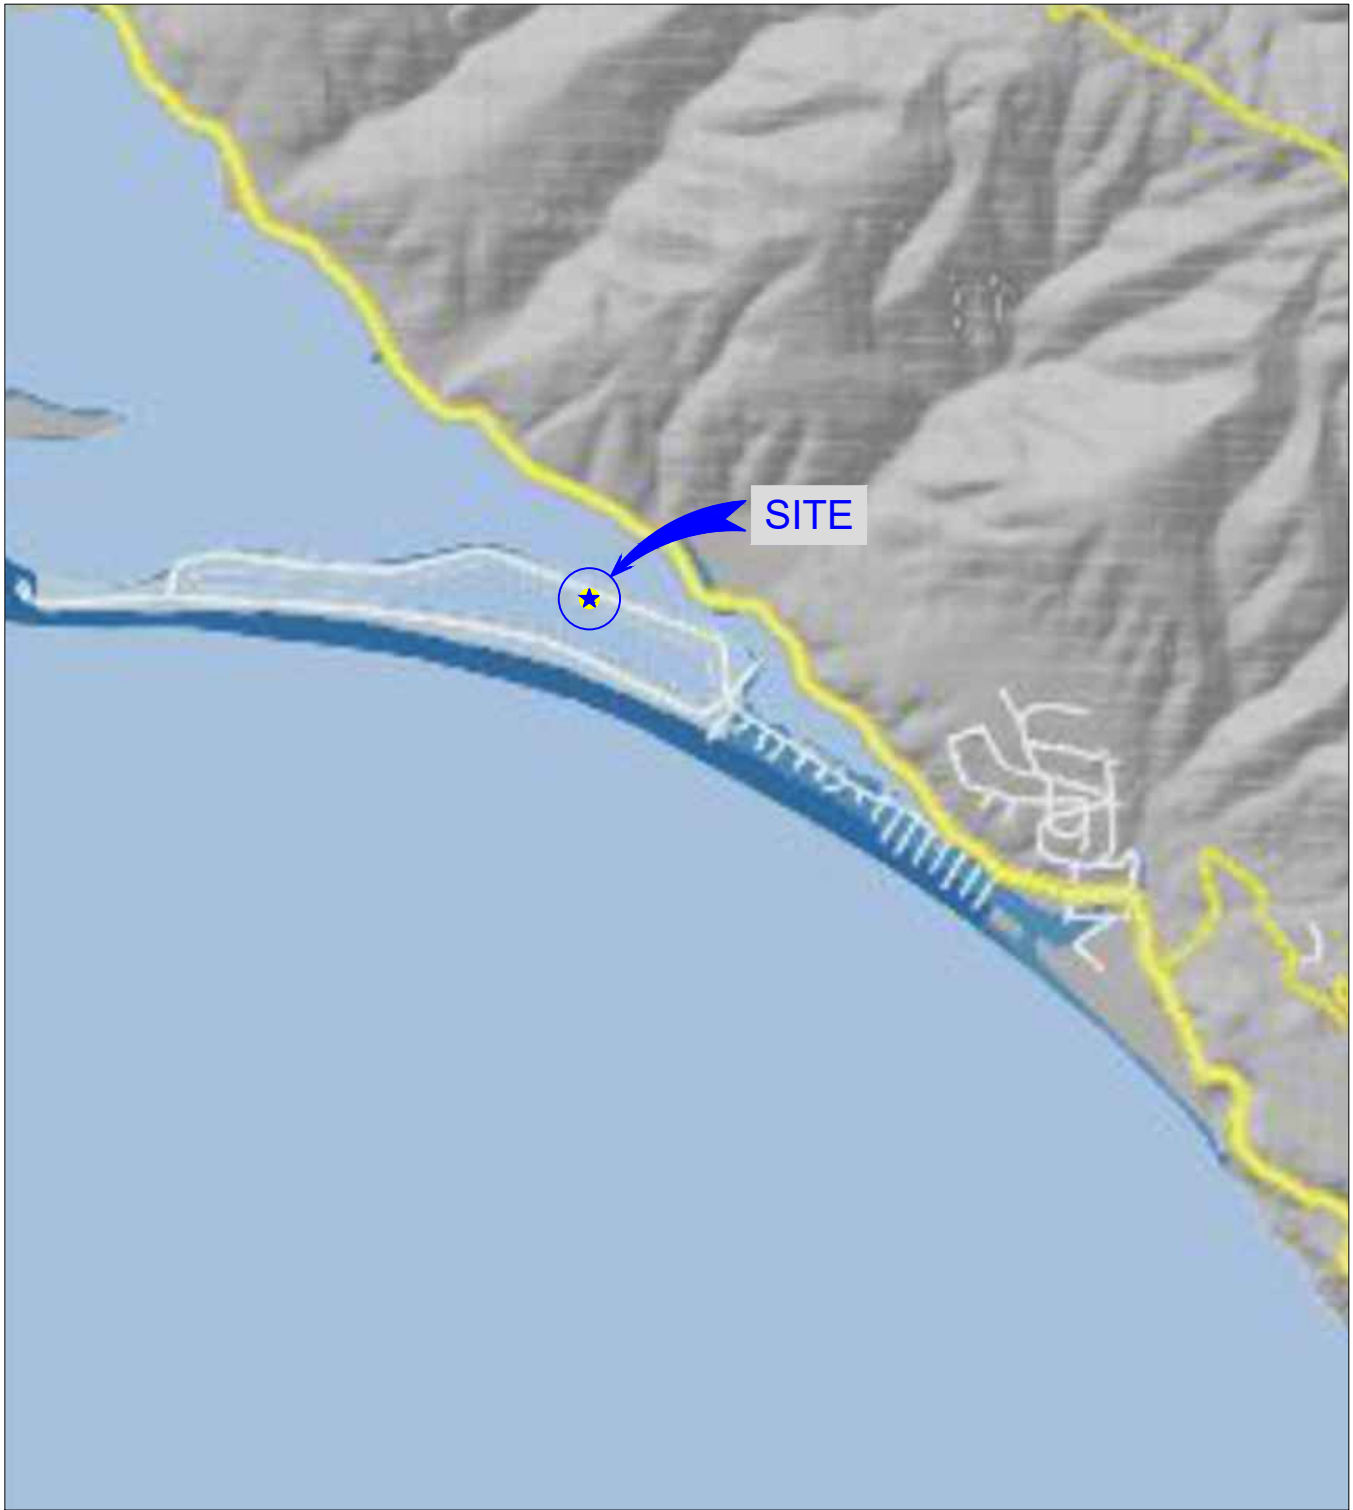
- Zone V- 100yr.
- Zone X - 500yr.
- Zone A - 100yr.
- Urbanized Area

Zone V: This code identifies an area inundated by 1% annual chance flooding with velocity hazard (wave action).
 Zone A: This code identifies an area inundated by 1% annual chance flooding.
