**Stormwater Control Plan
For Regulated Project
For
Spirit Living Group Senior Housing
55 Thomas Drive, Mill Valley CA
APN 034-012-26**

**JN 24114
June 4, 2025**

**Stormwater Control Plan for Regulated Project For
Spirit Living Group Senior Housing
15655 Arnold Drive, Glen Ellen California**

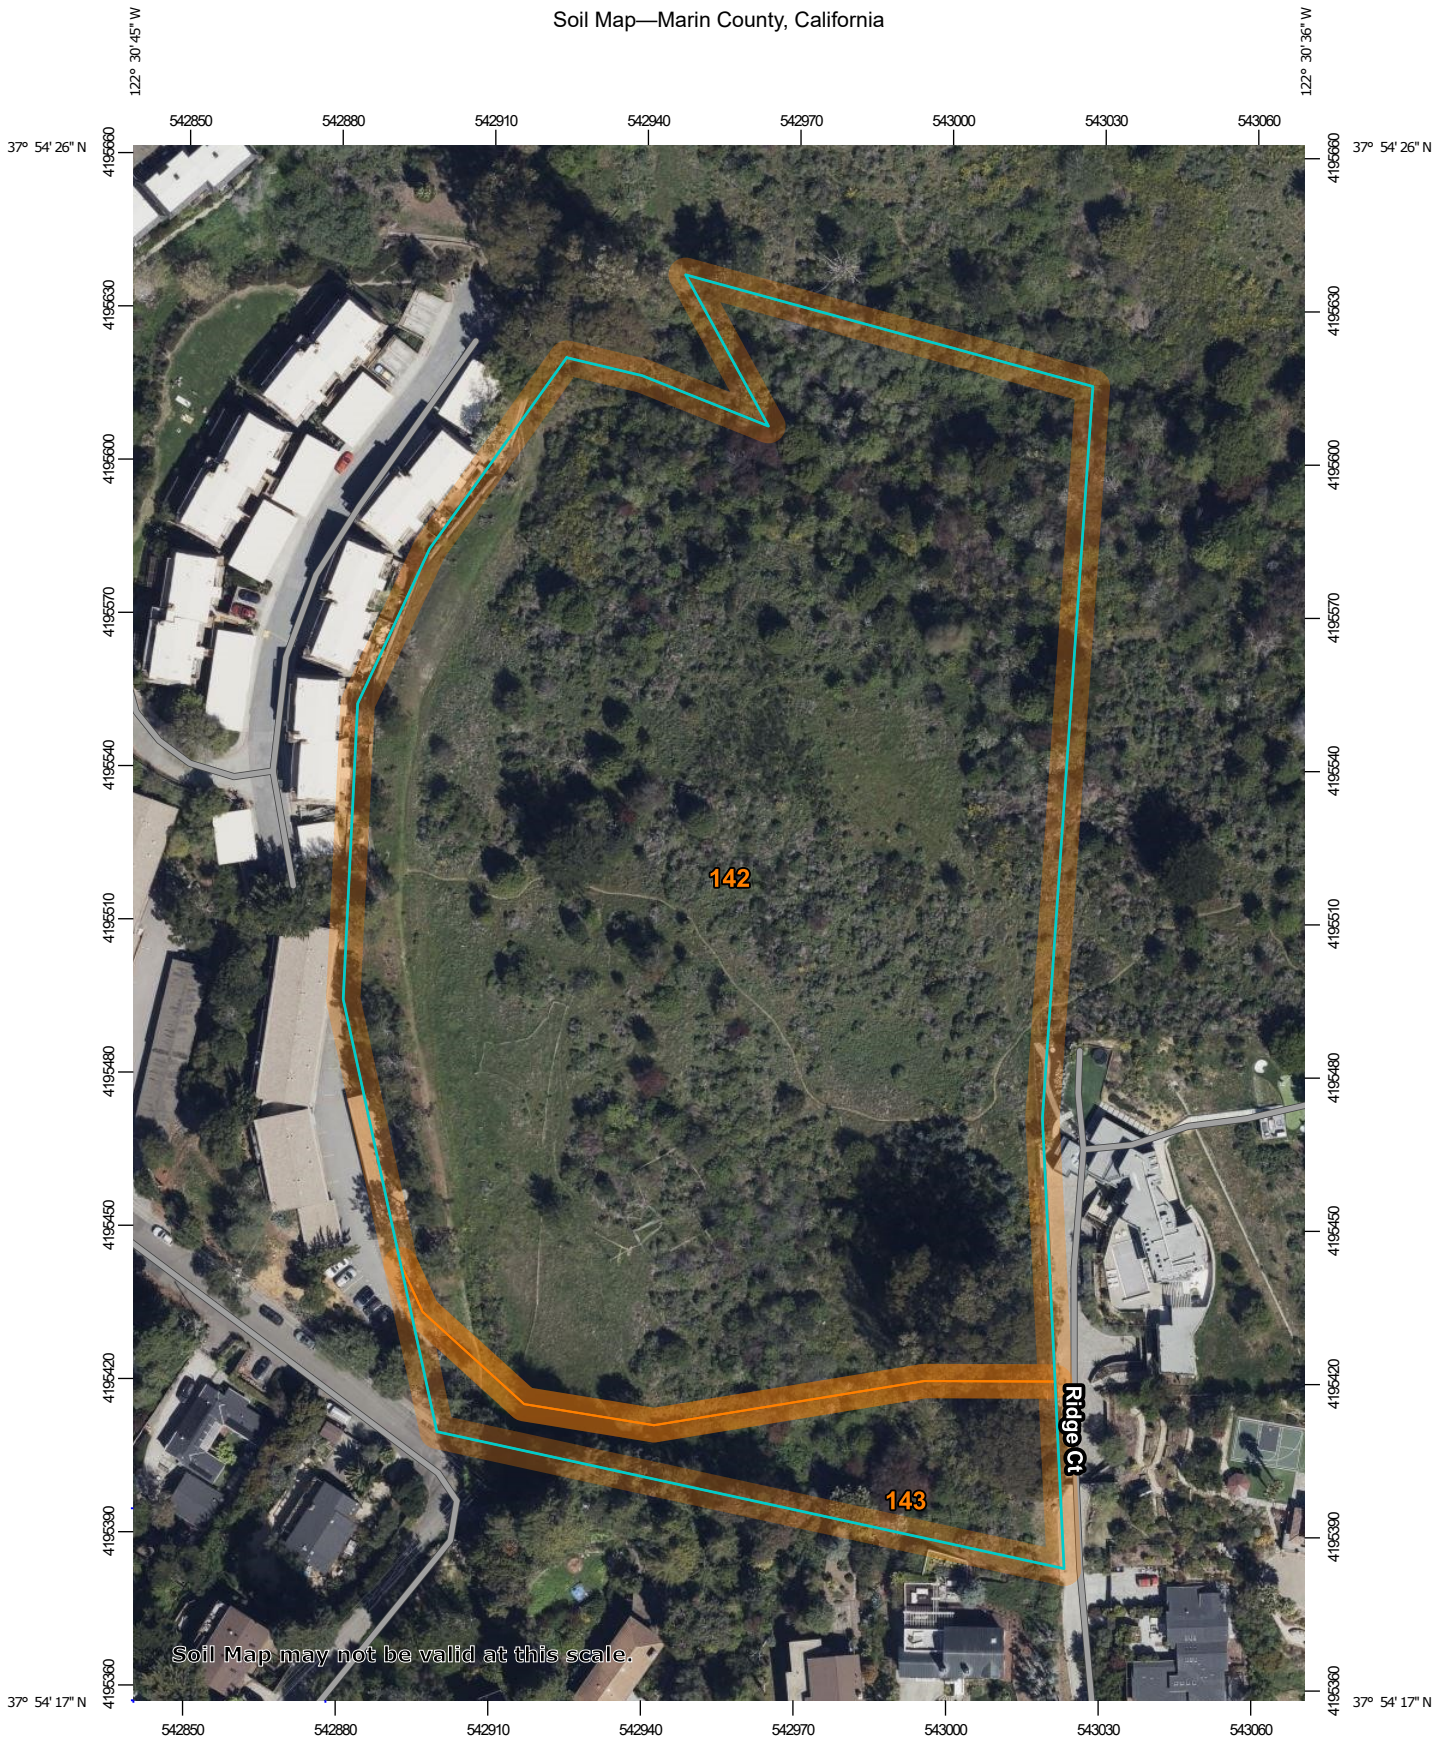
Soil Map—Marin County, California

Soil Map may not be valid at this scale.

The existing site is located on Thomas Drive in Mill Valley, California with existing slopes ranging from 15% to 50%. The project resides approximately 4,150 LF northwest of Richardson Bay. The existing parcel is approximately 6.02 acres. The site is undeveloped with existing brush and trees throughout. According to the United States Department of Agriculture (USDA) Web Soil Survey Program, the site contains Hydrological Soil Group D. See attached Soil Analysis in **Appendix F**.
