**GEOTECHNICAL FEASIBILITY EVALUATION  
OAK HILL AT SAN QUENTIN MULTI-FAMILY RESIDENTIAL DEVELOPMENT  
APN 018-152-12  
SAN QUENTIN, CALIFORNIA**

Project 1547.021

**GEOTECHNICAL FEASIBILITY EVALUATION**  
**OAK HILL AT SAN QUENTIN MULTI-FAMILY RESIDENTIAL DEVELOPMENT**  
**APN 018-152-12**  
**SAN QUENTIN, CALIFORNIA**

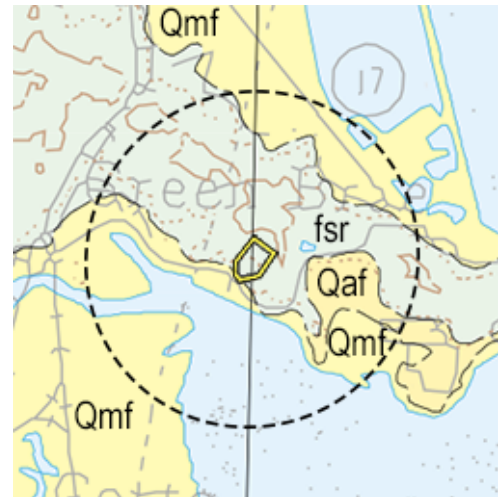
### Geologic Units

According to the part of the Blake et al. (2000) geologic map shown here, the entire project site (yellow outline) consists of Franciscan mélange (fsr), which abuts Holocene artificial fill over marine and marsh deposits (Qmf) at its southwestern end. Also in the half-mile search area (dashed outline) is another unit of artificial fill (Qaf).
