# J.3 | Geotechnical Engineering

**GEOLOGIC & GEOTECHNICAL INVESTIGATION  
FERNWOOD CEMETERY EXPANSION  
301 TENNESSEE VALLEY ROAD  
MILL VALLEY, CALIFORNIA 94941**

October 29, 2025

Job No. 1734.023

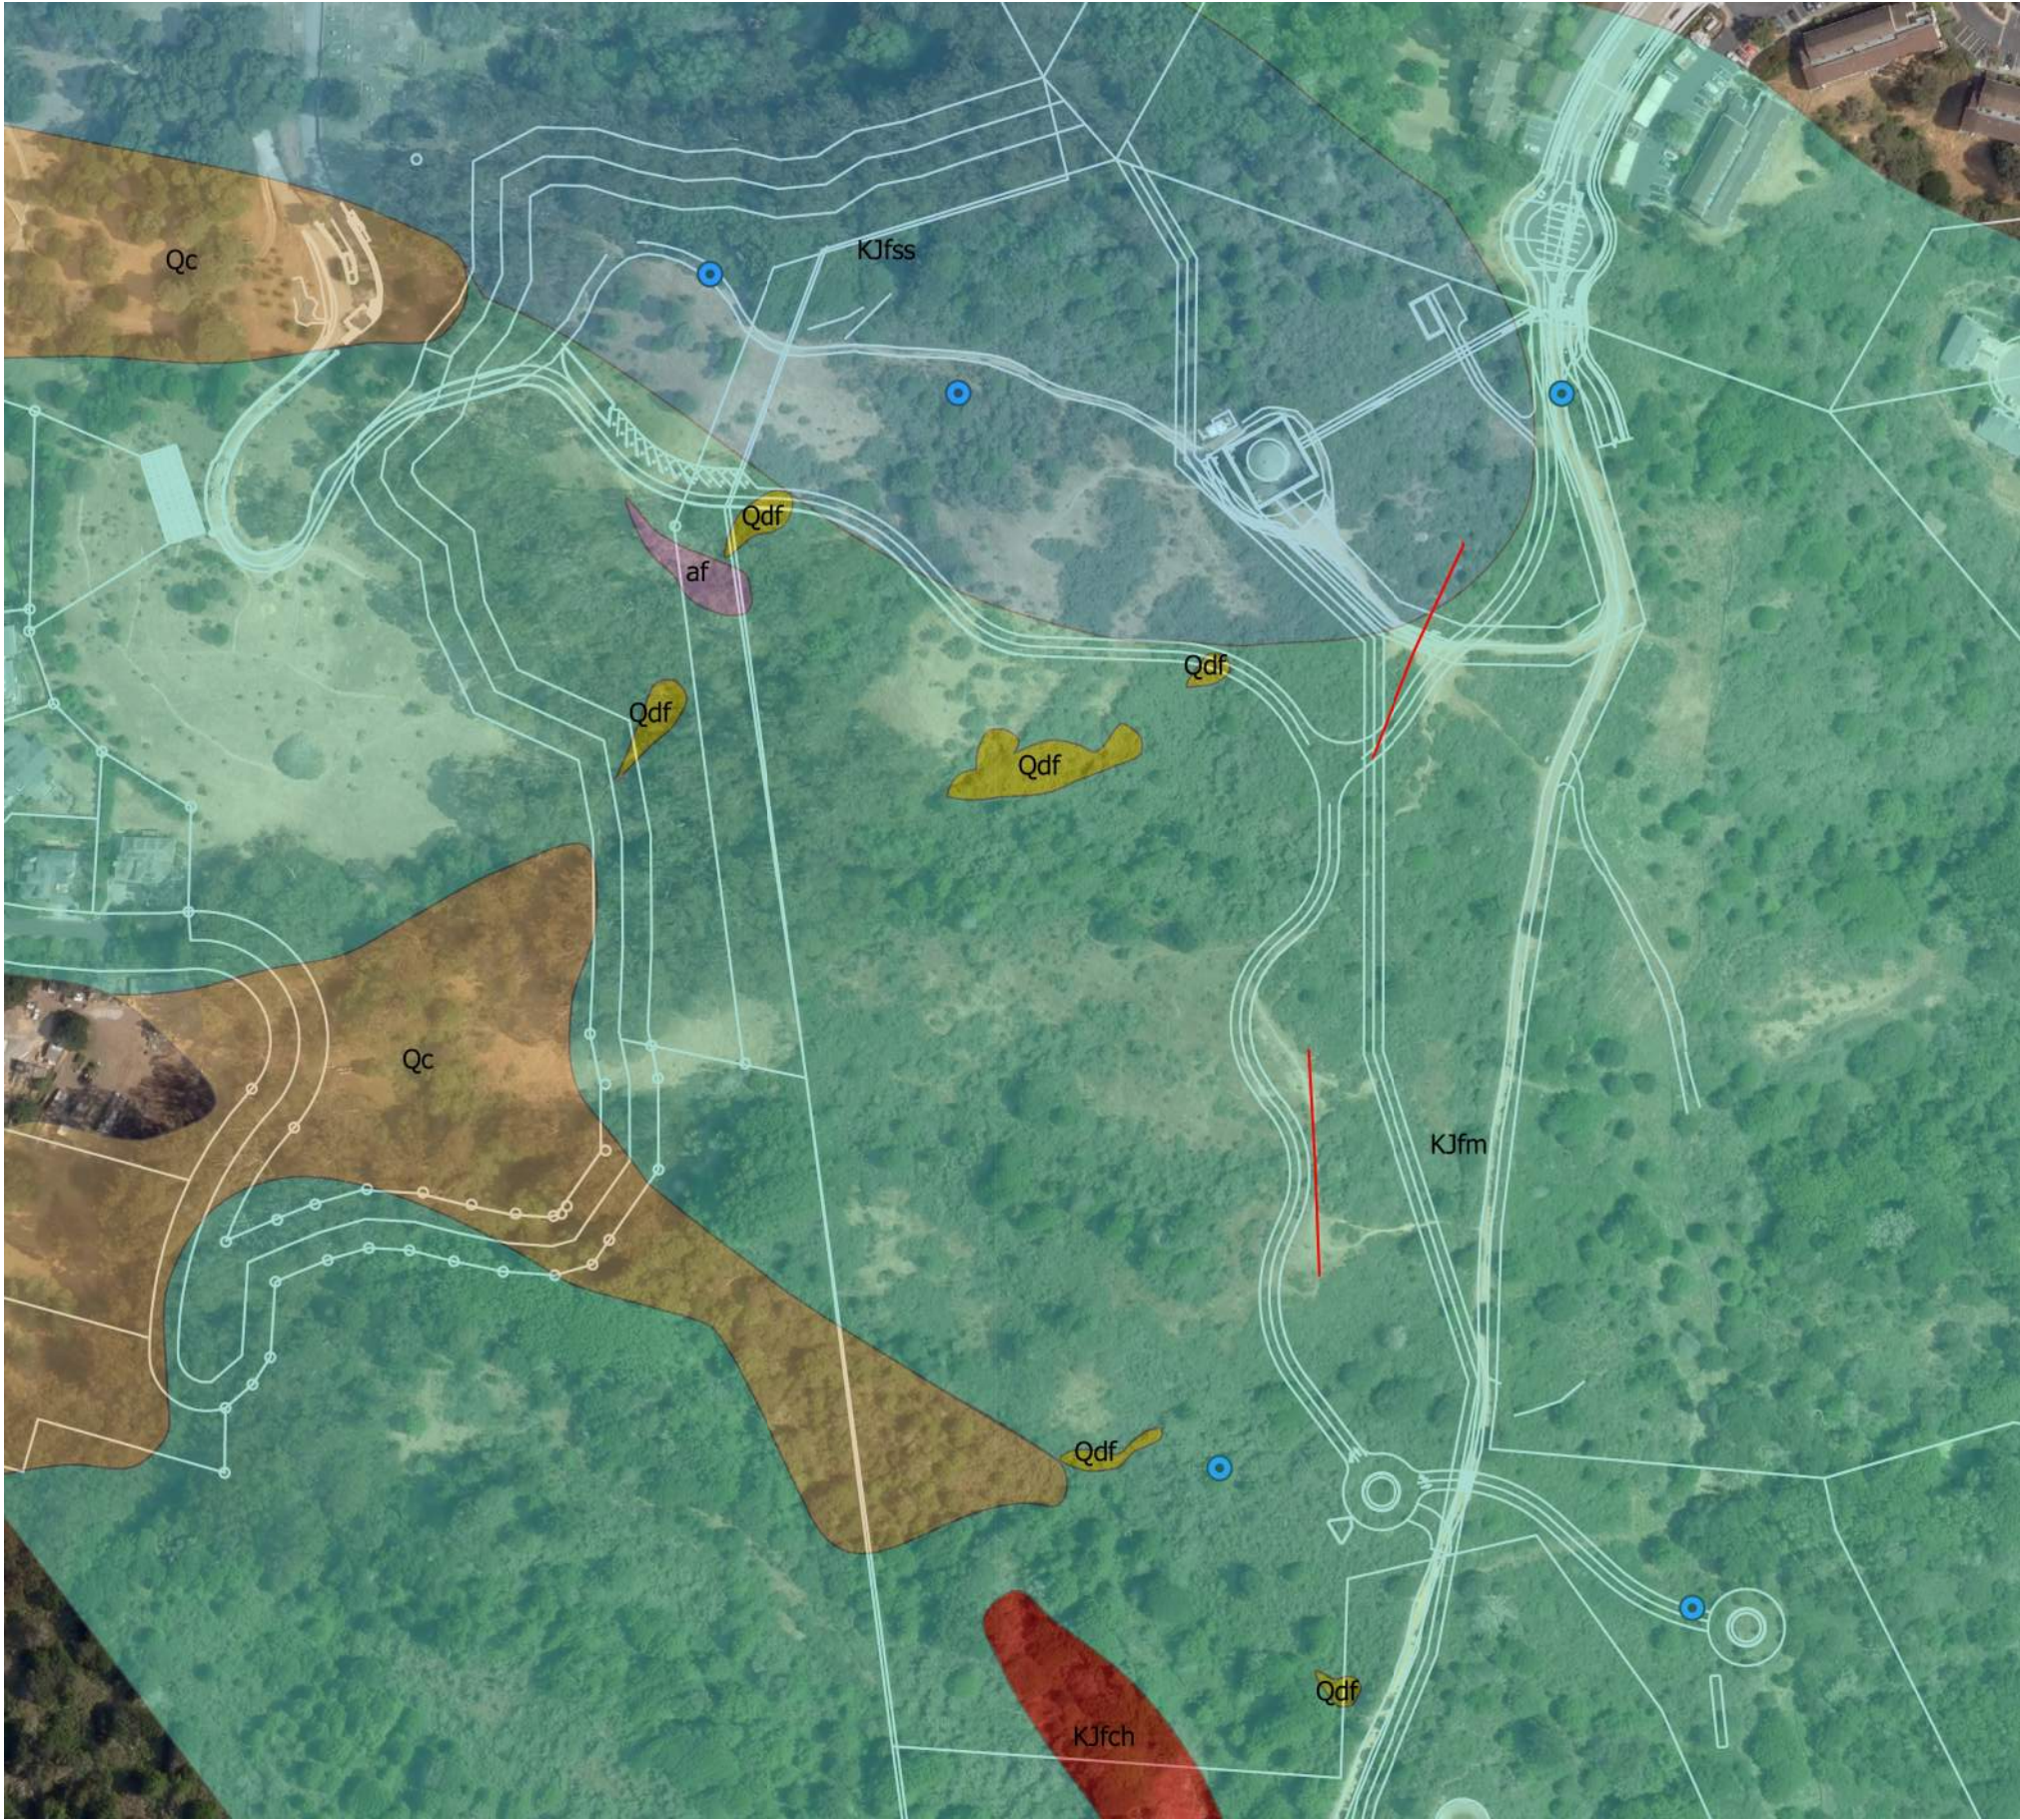
FIGURE  
6

- af Artificial fill: Deposits of rock, soil, garbage, and trash placed by man upon natural surfaces, mostly for engineering purposes.
- Qdf Landslide or Debris Flow Scars: Unit composed of deposits of unconsolidated and unsorted soil and rock debris that have moved downslope en masse or in increments due to flow or creep processes.

FIGURE 6: PRELIMINARY GEOLOGIC MAP

We observed the two landslides previously mapped by Miller Pacific in the northern portion of the site, on a southwest facing hillside during our 2022 work. We noted that scarps remain generally overgrown and as described in that report, and did not observe any significant evidence indicative of recent movement. We were unable to confirm other landslides mapped previously by Miller Pacific and observed in the aerial photographs, as those areas are typically obscured by very thick brush. The observed landslides are indicated on the Preliminary Geologic Map, Figure 6.
